6675A-11

S E R V I C E N O T E

**6675A - DC POWER SUPPLY, 0-120 V, 0-18 A, 2160 W.
GPIB CONTROLLED**

Serial Numbers: MY41000101/ MY41001580 SG41000101/ SG41000433

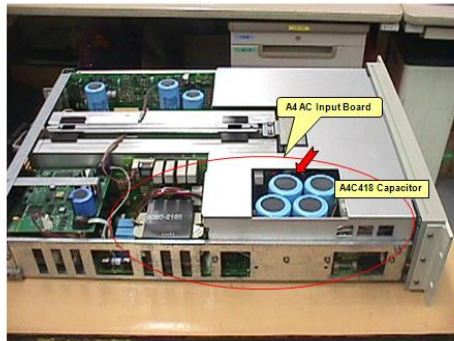
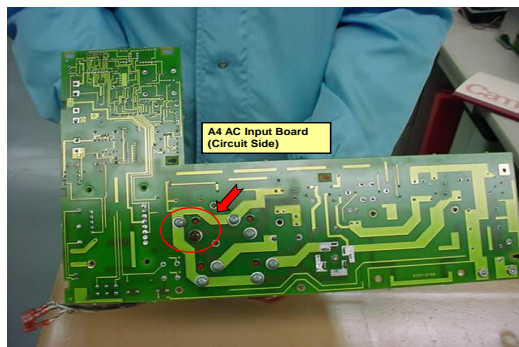
The four filter capacitors circuit reference (C416-C419) on the A4 AC input board starts leaking electrolyte - not through the pressure valve in the bottom as one would expect but through one of the terminal screw bushings.”

When this happens the electrolyte will slowly leak out over time, and cause the defect described. This situation is even worse due to the capacitor is mounted with the header face down. If the capacitor was mounted header face up a cracked or broken header would not have caused this problem, the electrolyte could not leak out.

1. All affected models and tested assemblies WIP (Work In Process), FGI (Finished Goods Inventory) at SPO (Support Parts Organization) & AMC (Asian Manufacturing Center) has been inspected for capacitors with damaged headers due to the incorrect screw
2. When this repair is being done all of the hardware described above should be replaced (It is NOT recommended that any of the hardware be reused)
3. The following figures can be used when doing the repair.
4. Inspect the assembly as described below.
5. The last figure will aid in the reassembly of the hardware and the capacitors.

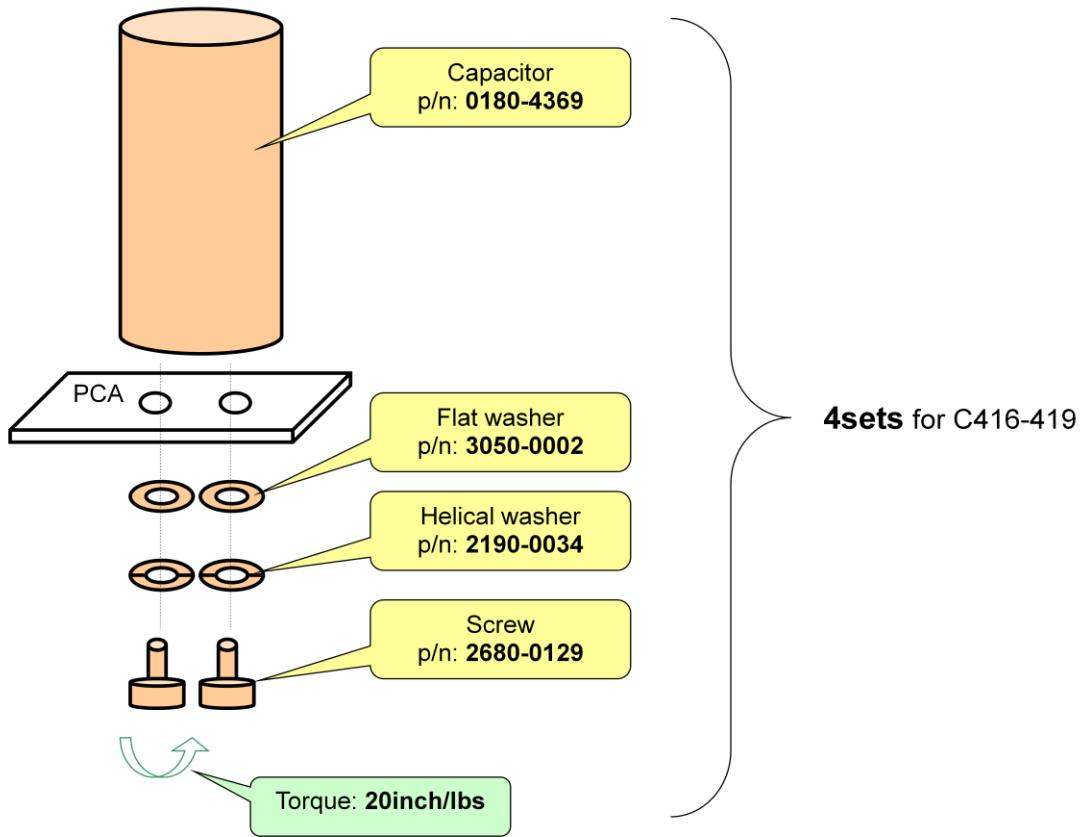
Replacement instruction for C416-419

The screw P/N 2680-0217 length currently being used was not considered and the length was overlooked. The screw length is 0.375 inches long. We have found that the screw can be 0.055 inches too long and may bottom out causing the tapped hole in the header of the capacitor to become cracked or become broken.
