6675A-12

S E R V I C E N O T E

**6675A DC POWER SUPPLY, 0-120V, 0-18 A, 2100 W.
GPIB CONTROLLED.**

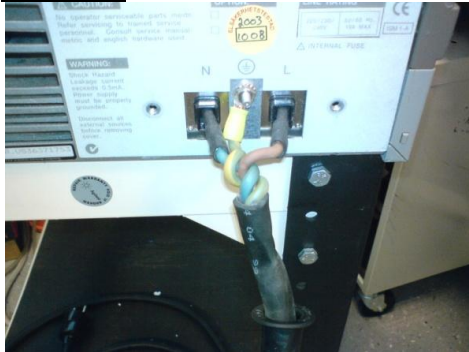
Figure 1 is an example of what happens when the strain relief becomes loose, the line cord becomes twisted. When a heavy line cord is used the strain relief becomes loose very easily, and the line cord cable can rotate freely.

The entire **AC INPUT SAFETY COVER** P/N 5040-1676 should be replaced.

The line cord should be securely fastened at a point 6 to 12 inches away from **INPUT SAFETY COVER** as shown in [Figure 7](#). When this type of strain relief is used the electrical code requires the cord/cable being held by the strain relief be secured. Doing this eliminates the cable or cord from being twisted as shown in figure 1.

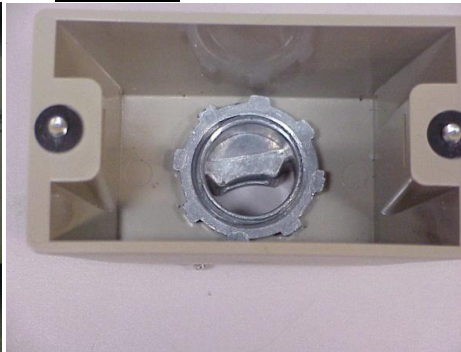
Figure 2 shows the inside of the AC Safety Cover housing the incorrect hardware is shown. It will be very difficult to tighten the strain relief. AMC (Asian Manufacturing Center) uses a special tool to tighten the locking nut. When the incorrect nut is used or a locking Nut is put on incorrectly the strain relief will become loose as described above.

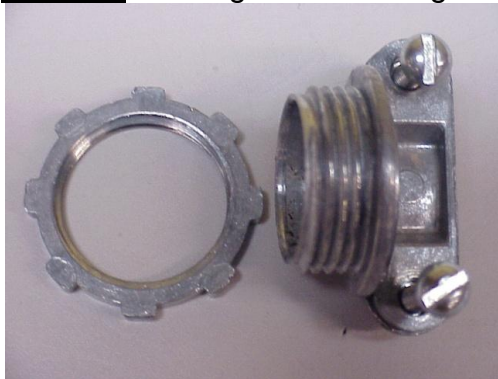
Figure 3 Regal Non locking Nut

Figures 3 & 5 is representative of a not without locking ribs.

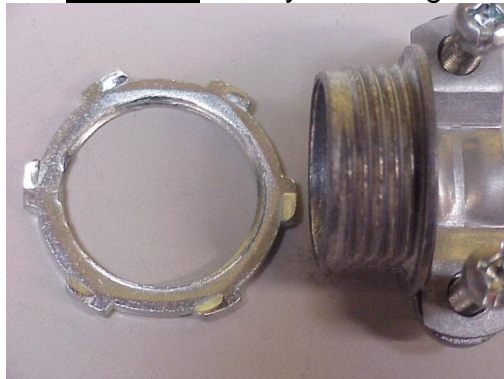
Figure 4 Heyco locking Nut

Figures 4 & 6 is representative of a nut with locking ribs.

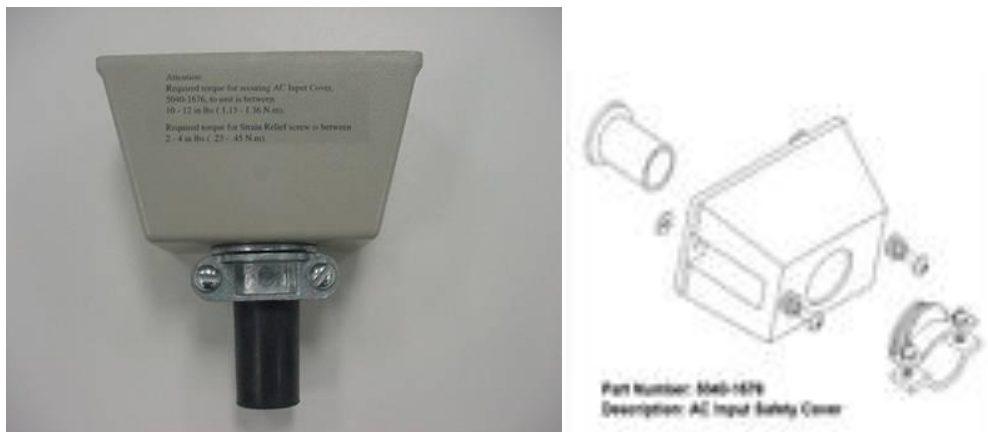
Figure 8

The individual parts shown in [Figure 8](#) are not available from Agilent parts “SPO” (Support Parts Organization). It is not cost affective to repair the **AC INPUT SAFETY COVER**, a special tool is required to tighten the nut shown in Figure 2.

The information below is what is printed on the label shown in [Figure 8](#)

Required torque for securing AC Input Cover,
5040-1676, to unit is between
10 – 12 in lbs (1.13 – 1.26 N.m).

Required torque for Strain Relief screw is between
tightened using 2inlb torque.

ONLY replace the AC Safety Cover P/N 5040-1676 if the label shown in [Figure 8](#) does not appear on the Safety cover or if the Cover is defective due to described failure, the Safety cover should be replaced at **NO** charge to the customer.
