# Modification Recommended Service Note

## 6675A DC power supply, 0-120 V, 0-18 A, 2160 W. GPIB

Serial Numbers: "MY53000140 to MY53000698 and SG53000101 to SG53000108"

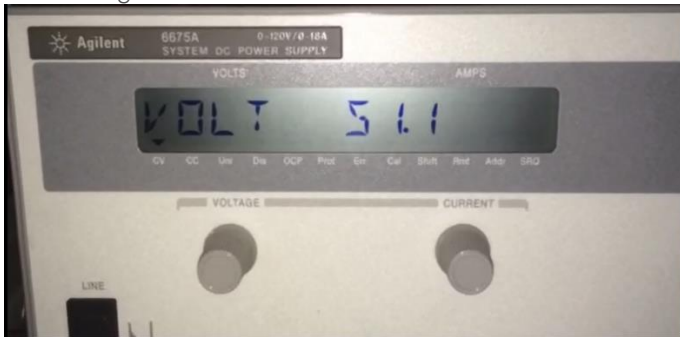
1. Set voltage to 51.1V and turn on the output. If the unit is good, the front panel will show voltage value (read back voltage) that is within the specification to 51.1V (+/-0.21V).

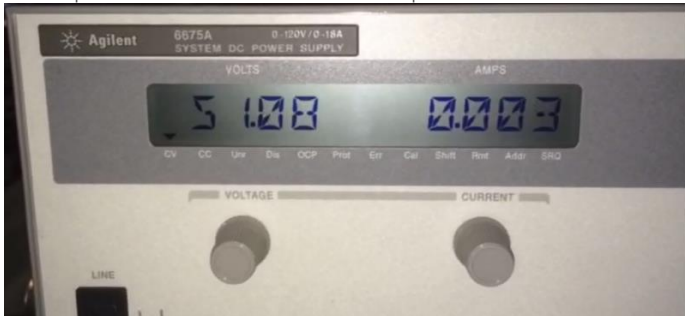
Turn on the output

Example: this unit is within the specification.

2. Any front panel voltage value reading out of 50.89V ~ 51.31V range is consider out of specification and need to send back to nearest SSU for PCA board replacement.
