6681A-08

S E R V I C E N O T E

6681A DC POWER SUPPLY

Serial Numbers: US0000000/US36400773 & MY41000101/MY41000176

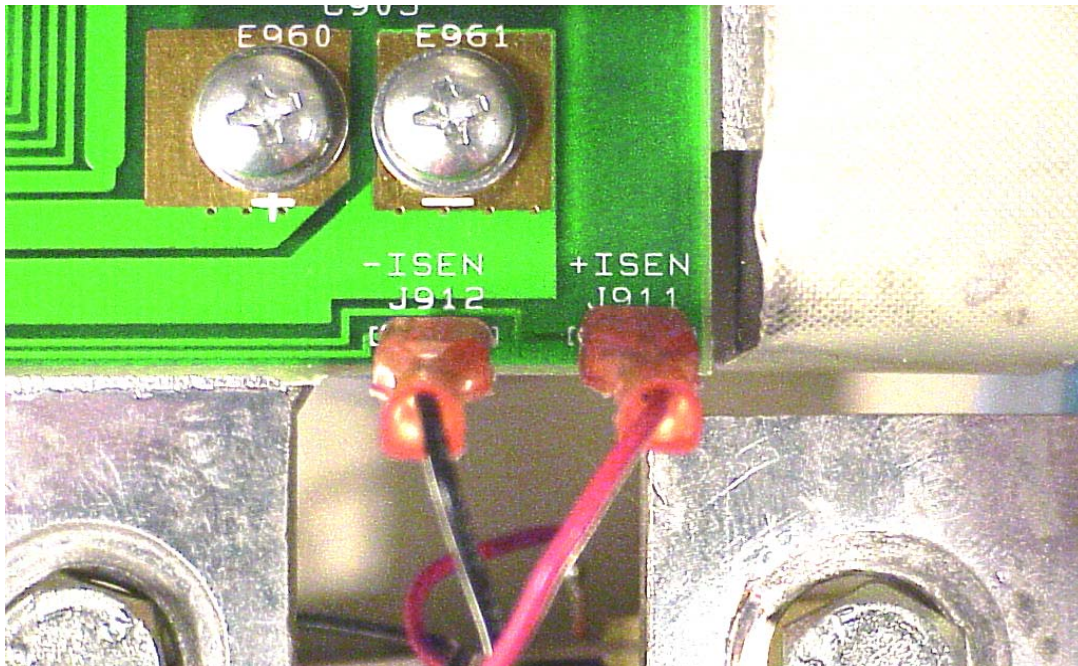
The Current Shunt (Circuit Reference “R900”) may have intermittent sense wires, which may cause Instability of Current Regulation, Current read back and current programming may become unstable.

When the push-on connectors become intermittent the output current will become unstable. Loose push-on connectors can cause the output current to change dramatically. The current can change from any set current, and may go to the maximum rated output current of the instrument.

The first picture below shows how the Shunt “R900” is connected using the term-crimp connectors. The Shunt “R900” is connected to (-ISEN J912 Black wire) & (+ISEN J911 Red wire).

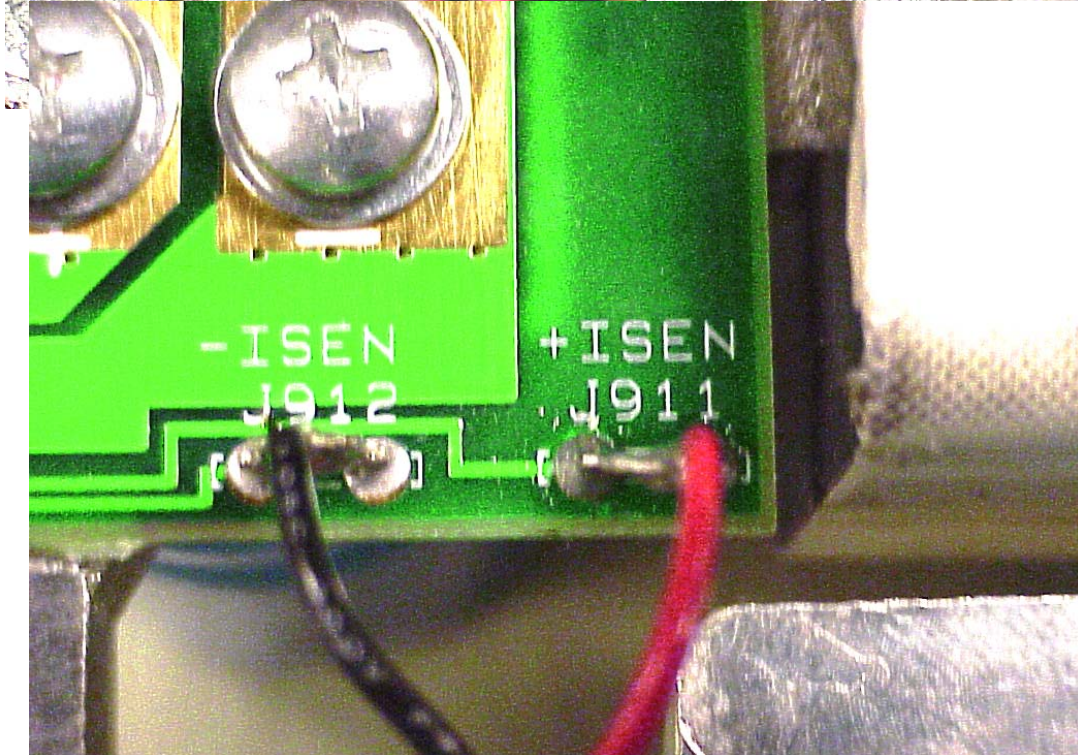
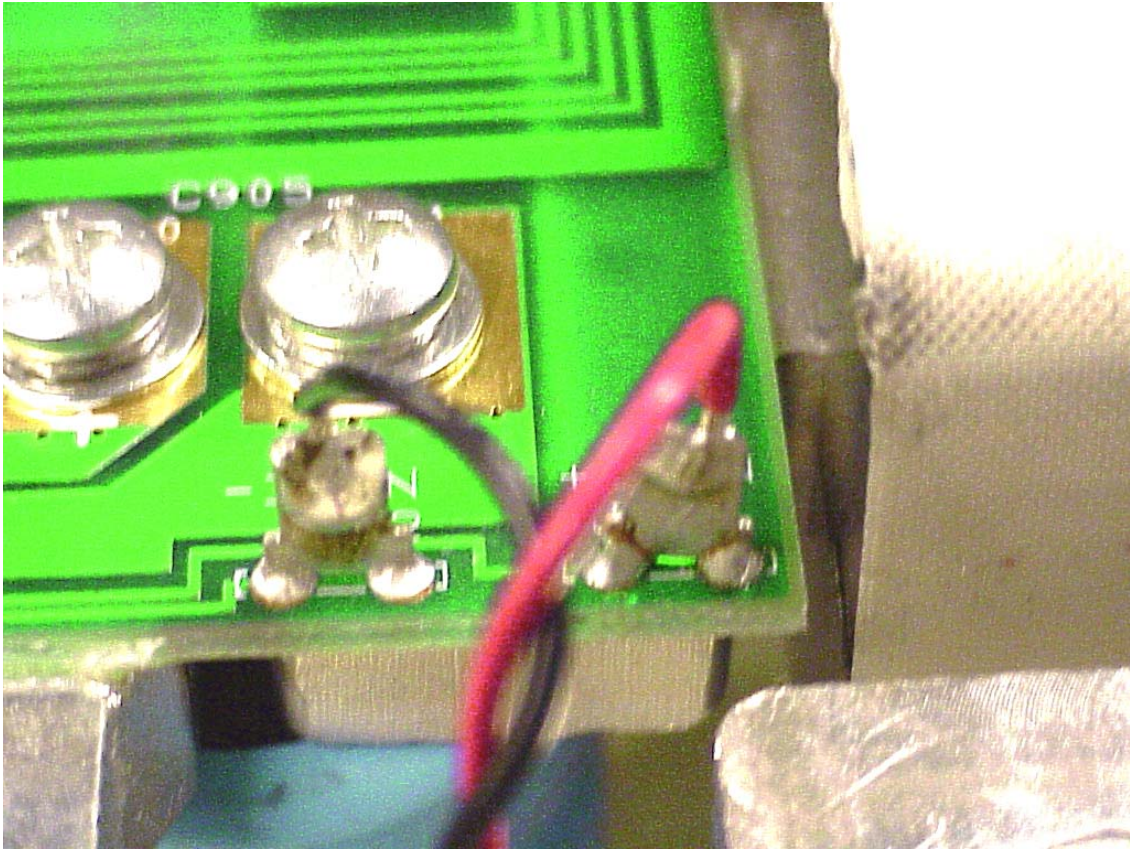
The second and the third pictures show how the Shunt “R900” is connected when soldered.

Cut the terminal-crimp connectors off of both wires and discard the connectors. Make this cut as close to the terminal-crimp connector as possible. Carefully strip the wires to approximately 8mm and solder the wires, and avoid burning the wire insulation and the printed circuit board.

This strip length will be used to solder to the connectors to (-ISEN J912 Black wire) & (+ISEN J911 Red wire). The length of these wires is critical. If the strip length of the wires is too long, the wires may cause a short to adjacent components. If the length of the wires is too short the solder connections may be poor. If replacement of the Red or the Black wire is required the same type and color wire should be used (22 AWG. 300V 105C).

The wires should be connected as shown below. The holes in the male connectors should be used to solder the Red and Black wires to the printed circuit assembly marked (-ISEN J912) & (+ISEN J911). Do not mix the Red & Black wires when making this modification. See picture below for details. The pictures shown below show the required modification.

1. Inspect the solder connections to determine the solder joints are acceptable.
2. Inspect the printed circuit board to insure the solder joints are acceptable around (-ISEN J912) & (+ISEN J911) connectors.
3. The wires that are now soldered to (-ISEN J912 Black wire) & (+ISEN J911 Red wire) MUST be twisted.
