MODIFICATION RECOMMENDED

6812B-03

S E R V I C E N O T E

6812B AC Source/Analyzer

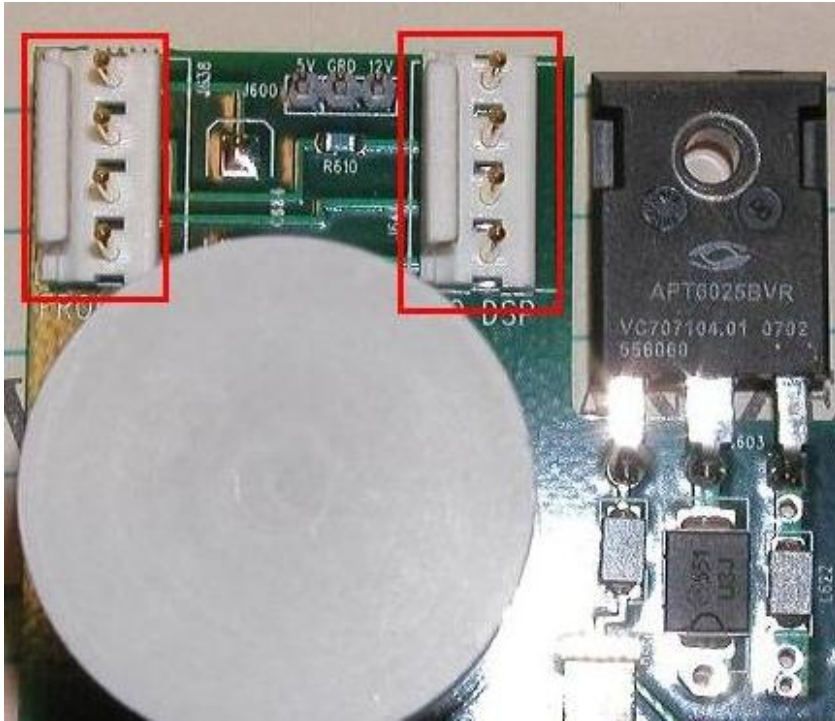
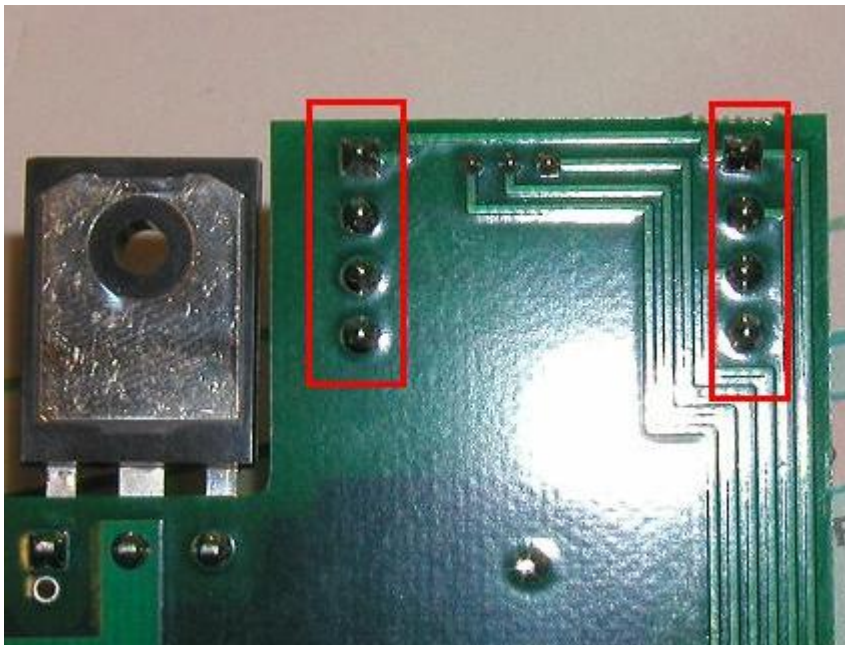
The tin plating on four PCA connector headers and one cable can potentially oxidize, causing contact resistance to increase. Higher contact resistance will cause a bias voltage on that is present on the connector header to sag. This low voltage can cause the unit to intermittently reset when it is below a certain threshold.

The first two connector headers are J638 and J646 on the A7 Inverter PCA. They need to be changed to the four pin connector, part number 1253-7410. These connectors should be fairly easy to de-solder.
