6812B-04

S E R V I C E N O T E

6812B AC SOURCE/ANALYZER, 0-300 VRMS, 750 VA, SINGLE-PHASE. GPIB, RS-232.

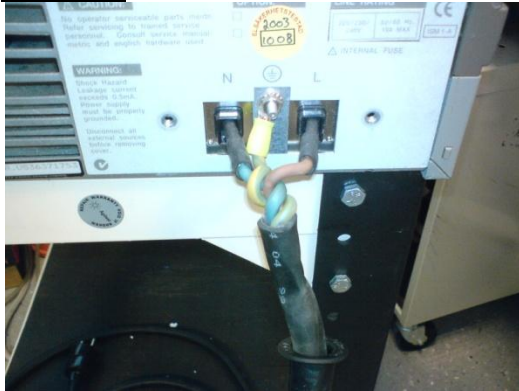
Figure 1 is an example of what happens when the strain relief becomes loose, the line cord becomes twisted. When a heavy line cord is used the strain relief becomes loose very easily, and the line cord cable can rotate freely.

The entire AC **INPUT SAFETY COVER** P/N 5040-1676 should be replaced.

The line cord should also be securely fastened at a point 6 to 12 inches away from **INPUT SAFETY COVER** as shown in [Figure 7](#). When this type of strain relief is used the electrical code requires the cord/cable being held by the strain relief be secured. Doing this eliminates the cable or cord from being twisted as shown in figure 1.

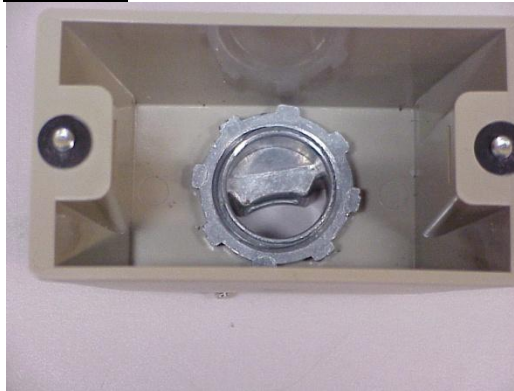
Figure 2 shows the inside of the AC Safety Cover housing the incorrect hardware is shown. It will be very difficult to tighten the strain relief. AMC (Asian Manufacturing Center) uses a special tool to tighten the locking nut. When the incorrect nut is used or a locking Nut is put on incorrectly the strain relief will become loose as described above.

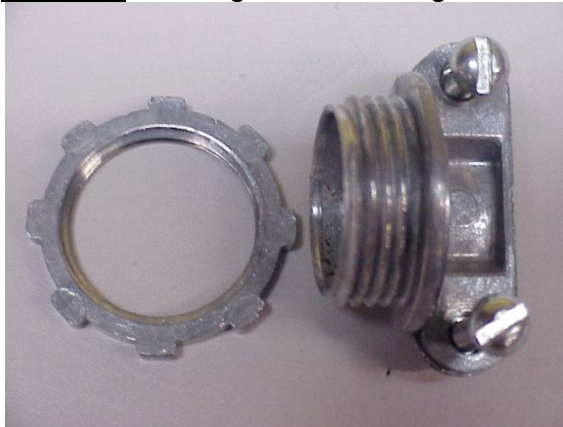
Figure 3 Regal Non locking Nut

Figures 3 & 5 is representative of a not without locking ribs.

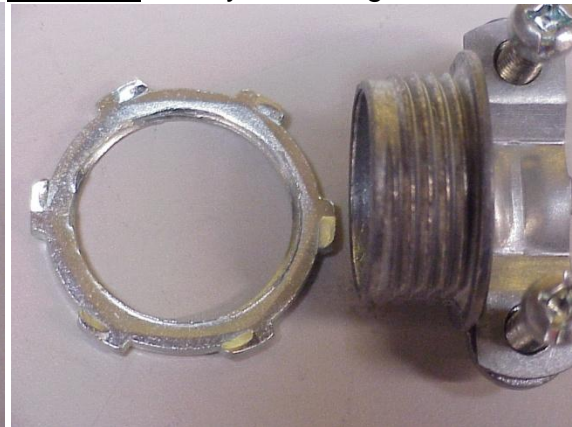
Figure 4 Heyco locking Nut

Figures 4 & 6 is representative of a nut with locking ribs.

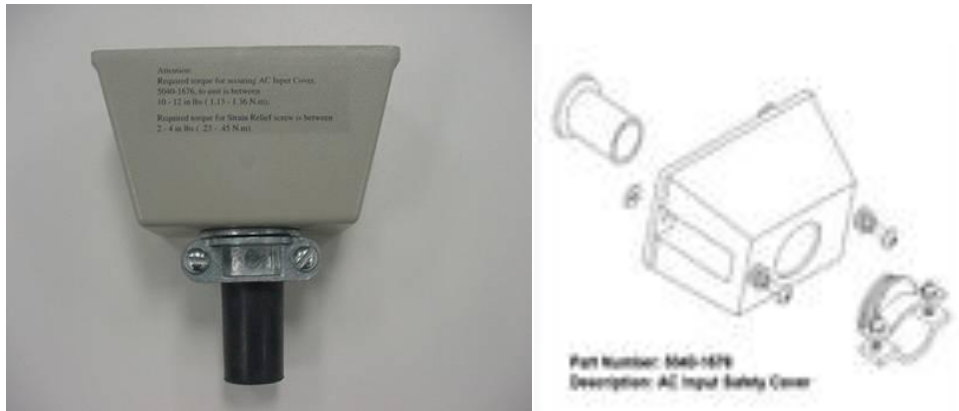
The individual parts shown in [Figure 8](#) are not available from Agilent parts “SPO” (Support Parts Organization). It is not cost affective to repair the AC **INPUT SAFETY COVER**, a special tool is required to tighten the nut shown in Figure 2.

The information below is what is printed on the label shown in **Figure 8**

Required torque for securing AC Input Cover,
5040-1676, to unit is between
10 – 12 in lbs (1.13 – 1.26 N.m).

Required torque for Strain Relief screw is between
tightened using 2inlb torque.

ONLY replace the AC Safety Cover P/N 5040-1676 if the label shown in Figure 8 does not appear on the Safety cover or if the Cover is defective due to described failure, the Safety cover should be replaced at **NO** charge to the customer.
