S E R V I C E N O T E

71612A 12 Gb/s HSBER System

70843 Serial Numbers: 3331U00135 / 3501U00163

This service note describes modifications to two of the 71612A 12 Gb/s HSBER system components. The units affected are the 70004A and the 70843A.

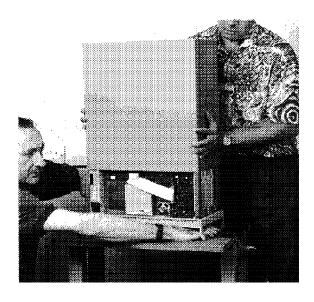
The cover can now be removed as shown in Figure 1. One person should hold down the handles while another person pulls on the sides of the cabinet cover from the rear of the unit.
