81133A-01A

# S E R V I C E N O T E

## 81133A- High Speed Pulse Generator

Serial Numbers: DE42800001-DE42800314

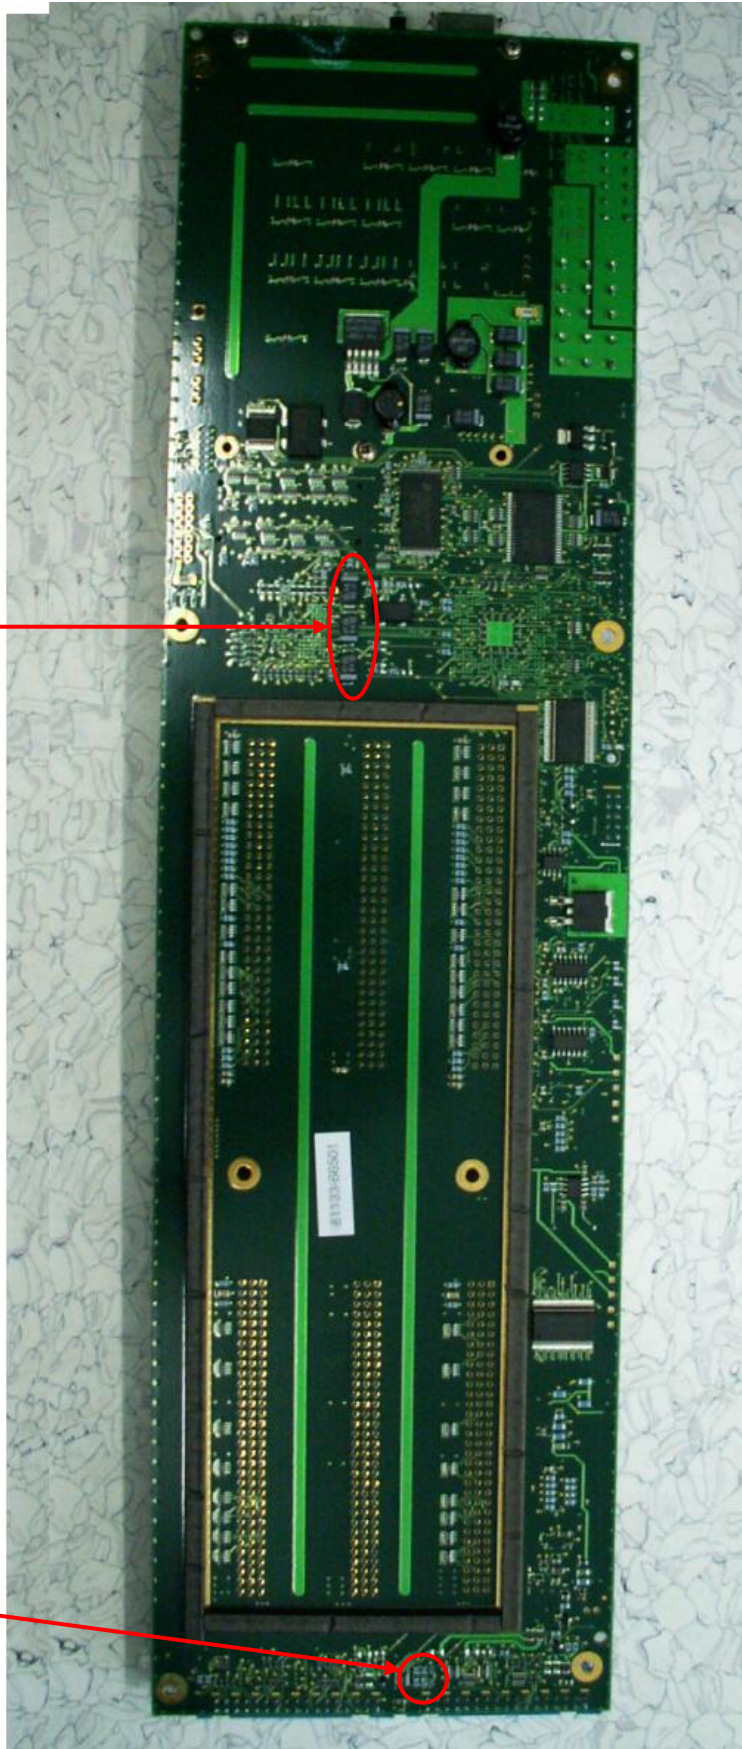
MOTHERBOARD  
BACK SIDE VIEW

Three polarized tantalum capacitors on the motherboard are connected with the wrong polarity. The polarized tantalum capacitors are normally more sensitive than others, so they tend to fail after some months. Due to this, wrong voltages were delivered to the front panel board which in turn affected the display.

Polarized Capacitors

Extra Resistors

The preventive maintenance to avoid flickering display failures requires removing the 3 capacitors shown in the following picture. And replacing them with new capacitors (part number 0180-4758) while mounting them with the correct polarity.

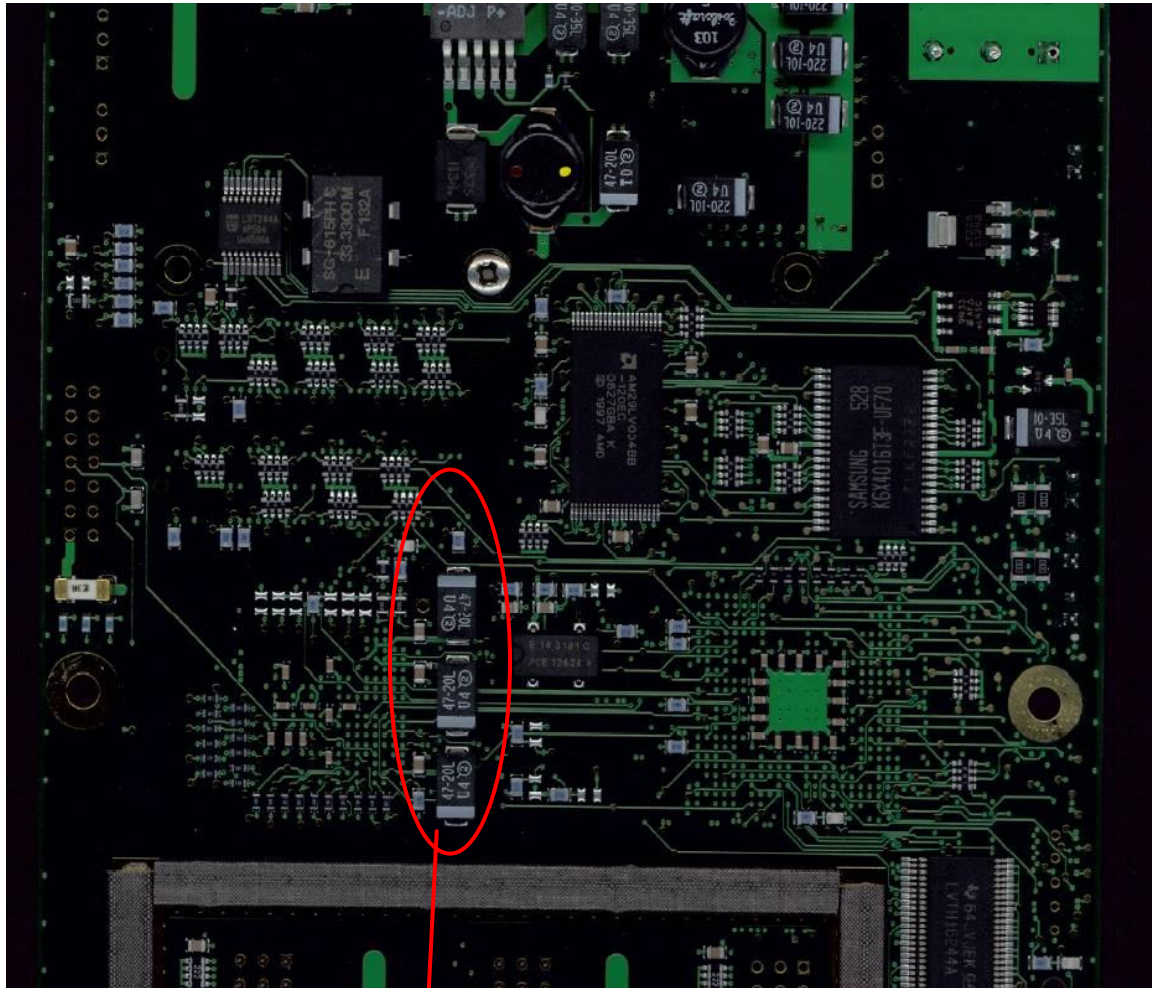
CLOSE UP VIEW WHERE THE CAPACITORS ARE LOCATED

Capacitors mounted with the wrong polarity. The positive side is shown with the white/grey stripe. These 3 capacitors need to be removed.

The capacitors are best removed using hot air. The new capacitors need to be mounted using standard soldering equipment.

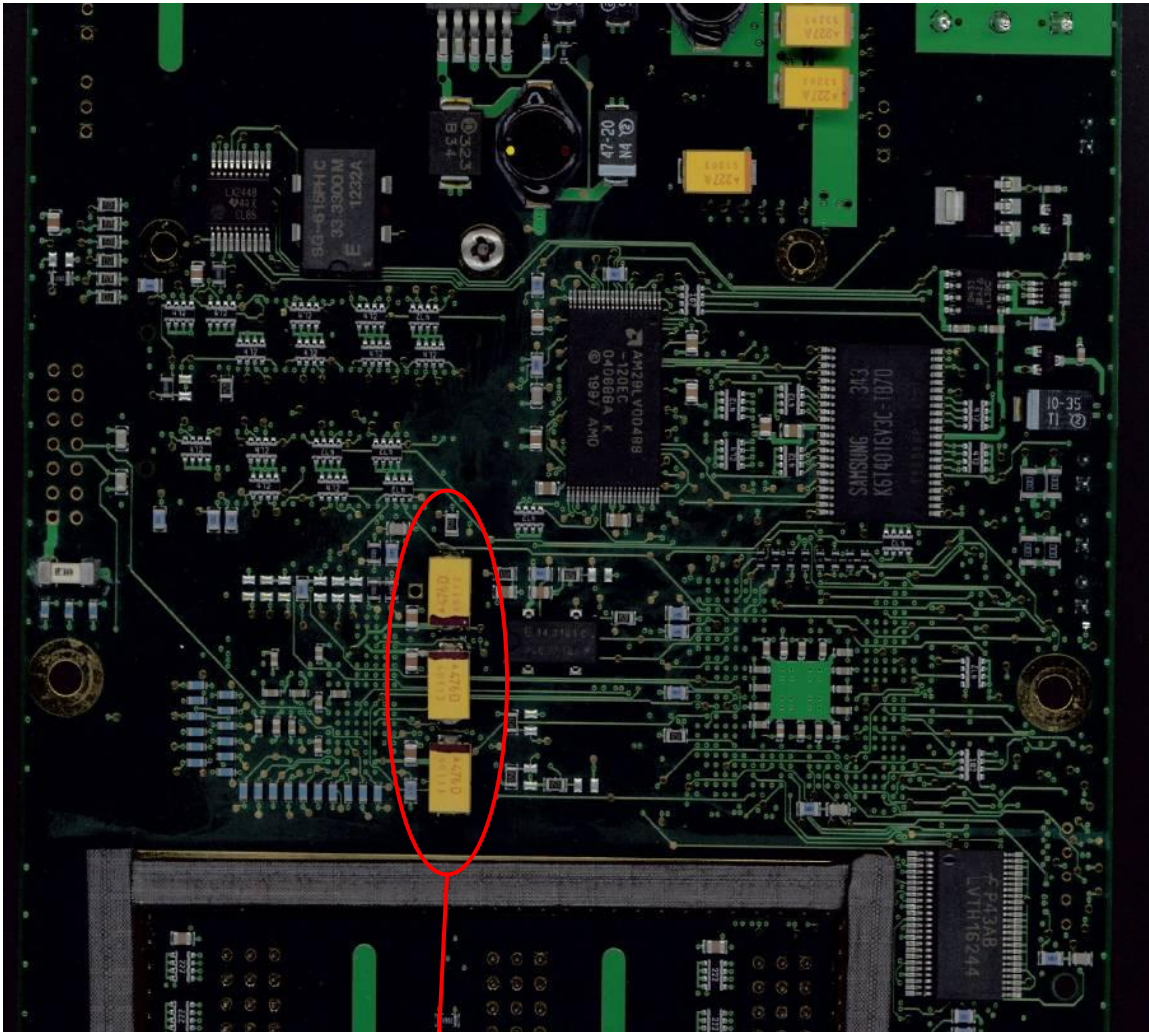
CLOSE UP VIEW WHERE THE CAPACITORS ARE LOCATED

This photo shows the capacitors mounted with the right polarity. The positive side is shown with the black stripe. The colors might vary.

By applying new capacitors and mounting them with the right polarity failures can be prevented for the future.

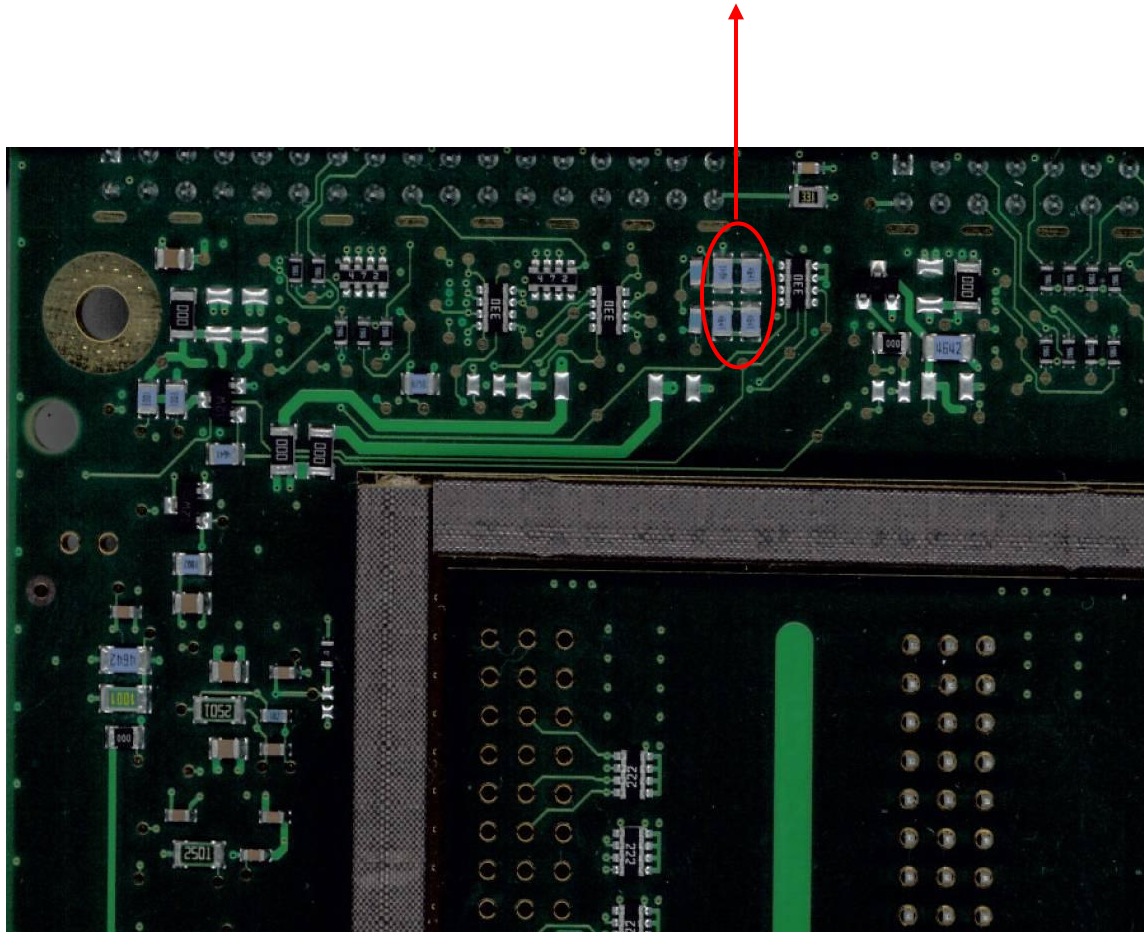
The rotary encoder (APN 0960-1055) has failed in some cases due to incorrect pull up resistance of the encoder. The pull-up resistance of this encoder as specified by the manufacturer is minimum 2.2 K Ohms. According the schematic of the front panel in the 81134A, the pull-up resistance used was 1.5 K Ohms. The lesser resistance value had possibly led to the flow of more currents into the encoder and had degraded the performance of it over a period of time.

Resistors to be removed ( The colours can be different)

By removing a few parallel resistors the resistance can be increased, preventing failures of the rotary encoder in the future.

For the preventive maintenance of the know problem the following 4 resistors need to be removed. They are best removed using hot air.

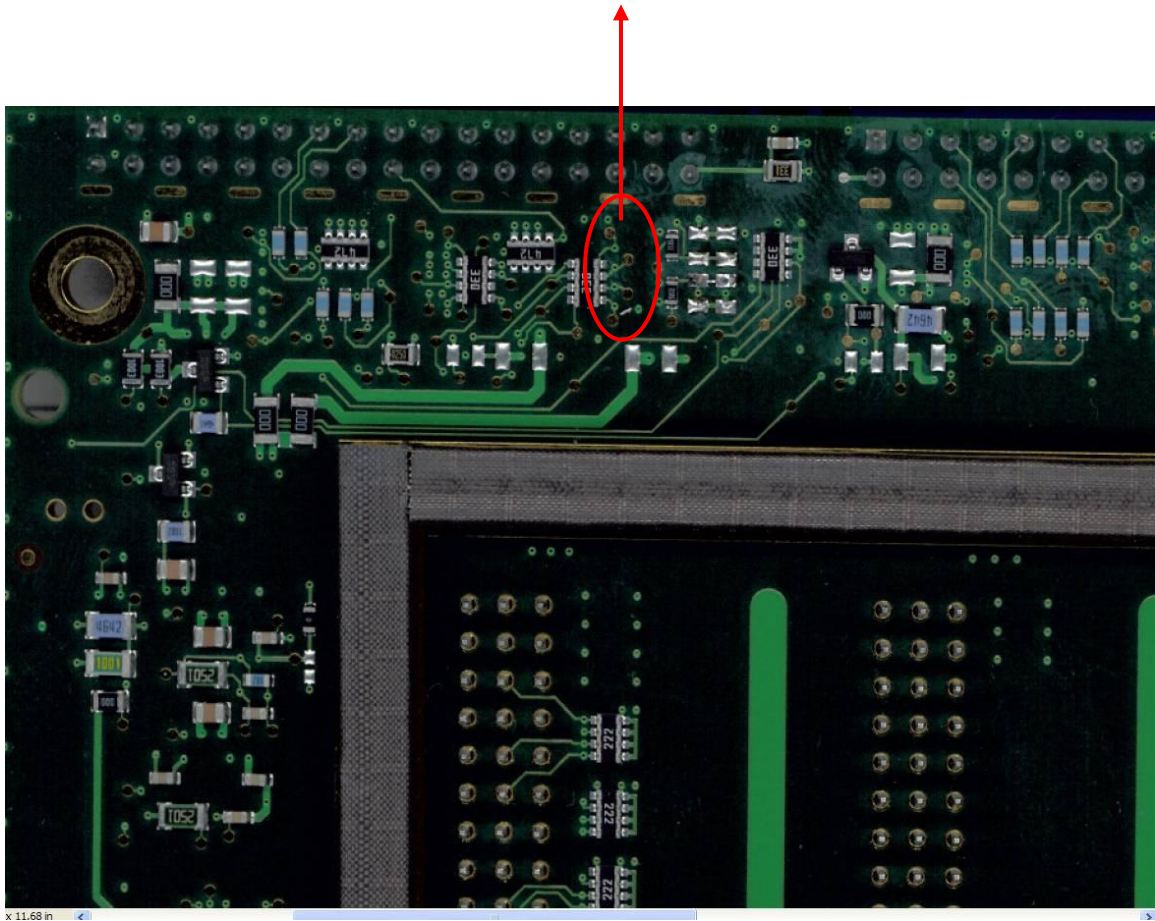
CLOSE UP VIEW – THE RESISTORS ARE REMOVED

The place where the 4 resistors are removed
