81141A-01A-S

S E R V I C E N O T E

81141A - 7 GHz Serial Pulse Data Generator

POSSIBLE FIRE HAZARD

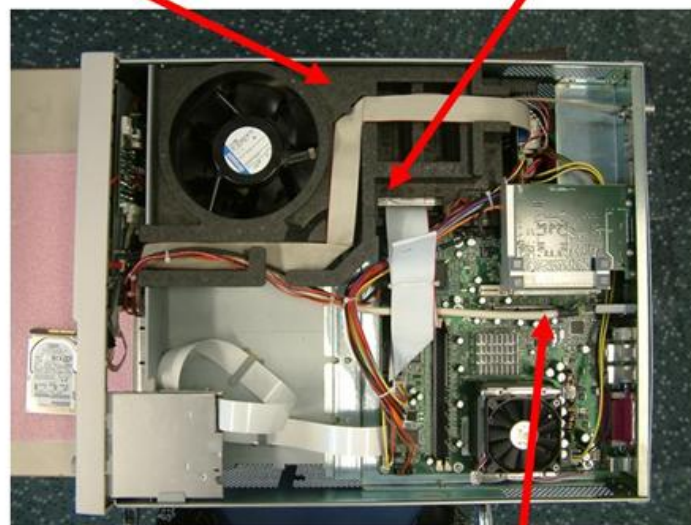
2. Inside View and Initial Inspection

Start of Fire

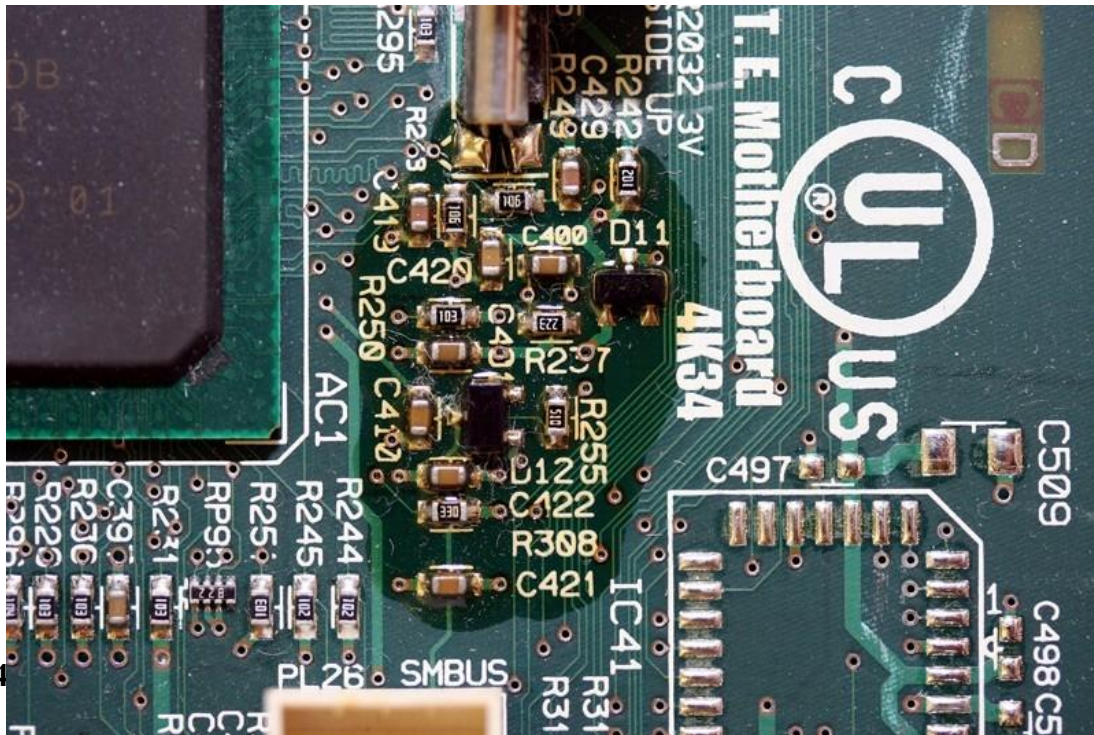
The following discoloring is intentional – no exchange required:

This effect is caused by an intentional sealing of a high impedance area to avoid issues in environments with a high degree of humidity. No exchange of the motherboard is required here.
