81160A-02

Modification Recommended Service Note

81160A - 1 or 2 Channel Pulse Function Arbitrary Generator

Potential issue with duplicate MAC address

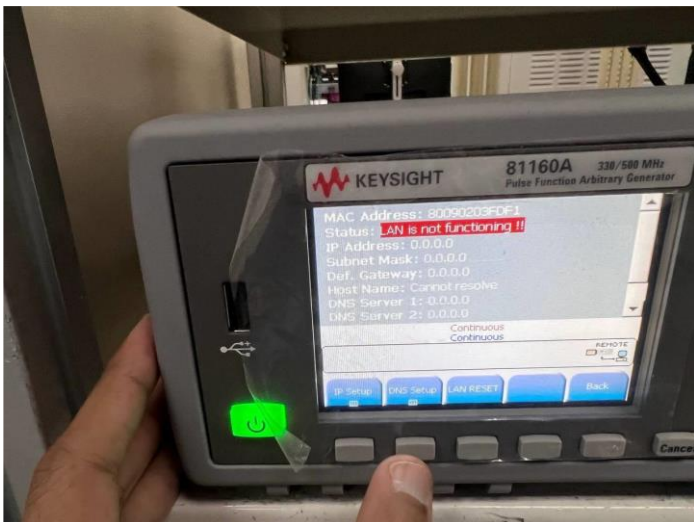
4. Press LAN button to reach LAN interface

All units which are carry MAC Address “80 09 02 03 FD FF” are affected. Please send the units back to Keysight for repair with reference information to this service note.

To renew the MAC address into instruments, it is required to return the instrument to Keysight.
