8495A-02

Modification Recommended Service Note

8495A – Manual Step Attenuator

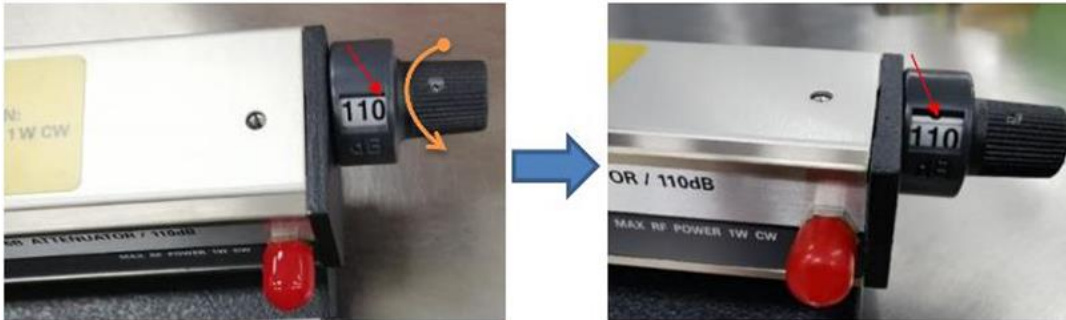
The attenuation knob was not securely tightened to the internal shaft, causing it to turn further. This is due to an insufficient torque that was applied to tighten the set screw during assembly at the factory.

This issue can be fixed by re-tightening the screws on the rotating knob.
