## S E R V I C E N O T E

HP 8566B Spectrum Analyzer  
 HP 8567A Spectrum Analyzer  
 HP 8568B Spectrum Analyzer  
 HP 85662A IF-Display Section

**Misloaded Capacitor Exposed to 130% of Its Rating**

DATE: 25 May 1990

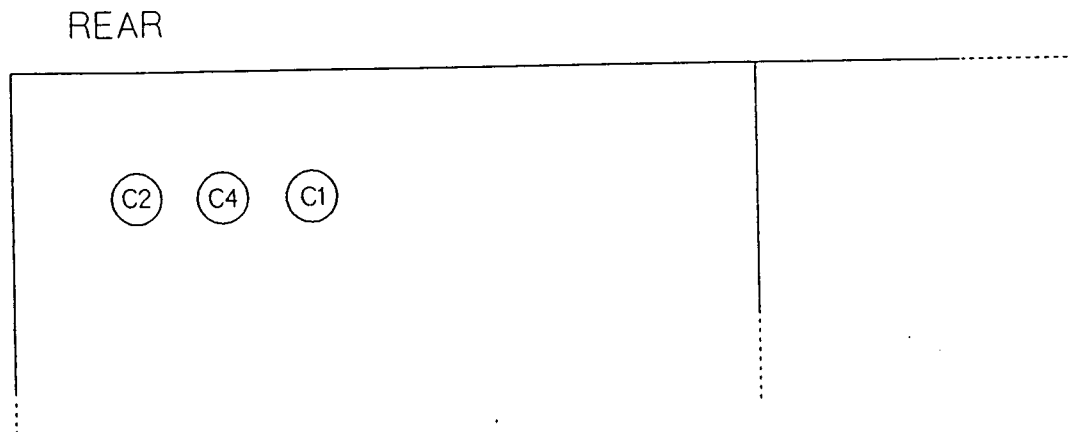
**Figure 1. Location of A1A10C1 and A1A10C4**

The two capacitors affected are A1A10C1, 22000  $\mu$ F (HP part number 0180-2808), and A1A10C4, 8700  $\mu$ F (HP part number 0180-0453). They are located along the HP 85662A rear frame, behind the CRT. Both capacitors are the same physical size.

1. Remove the power cords and interconnect cables from the rear of the spectrum analyzer.
2. Loosen the lock feet and separate the RF and the IF sections; set the RF section aside.
3. Remove the 2 rear feet near the top of the IF-Display Section.
4. Remove the top cover and check for proper position of the capacitors (A1A10C1 and A1A10C4). See Figure 1.

8. Remove the 4 screws securing A1A10C1 and A1A10C4 to the motherboard.
9. Remove the existing capacitors and replace with new capacitors, making sure the A1A10C1, 22000  $\mu$ F (HP part number 0180-2808), and A1A10C4, 8700  $\mu$ F (HP part number 0180-0453), are in the correct locations.
10. Reinstall the bracket, top cover, bottom cover, and the 4 rear feet.
11. Mate the IF and RF sections and reconnect cables. No calibration is required.
