S E R V I C E N O T E

HP 8566B Spectrum Analyzer
 HP 8567A Spectrum Analyzer
 HP 8568B Spectrum Analyzer
 HP 85662A IF-Display Section

Misloaded Capacitor Exposed to 130% of Its Rating

DATE: 25 May 1990

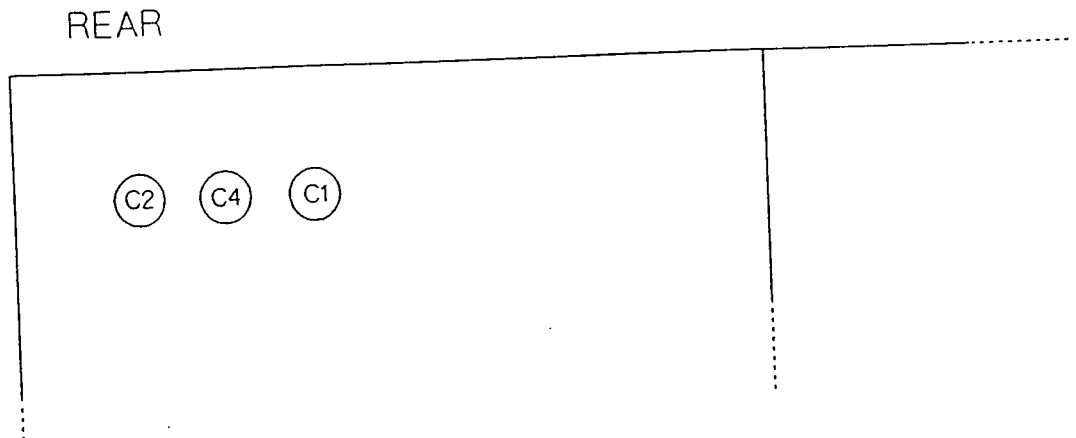
Figure 1. Location of A1A10C1 and A1A10C4

An assembly process variation was discovered that might have resulted in two large electrolytic power supply capacitors being installed in the wrong location in HP 85662A IF-Display Sections within the serial range listed above. When installed in the wrong location, one of the capacitors can be exposed to as much as 130% of its rating. This would probably result in a premature capacitor failure, with possible venting of the capacitor electrolyte onto the bottom of the IF-Display Section. Venting might cause damage to other components and assemblies.

The two capacitors affected are A1A10C1, 22000 μ F (HP part number 0180-2808), and A1A10C4, 8700 μ F (HP part number 0180-0453). They are located along the HP 85662A rear frame, behind the CRT. Both capacitors are the same physical size.

1. Remove the power cords and interconnect cables from the rear of the spectrum analyzer.
2. Loosen the lock feet and separate the RF and the IF sections; set the RF section aside.
3. Remove the 2 rear feet near the top of the IF-Display Section.
4. Remove the top cover and check for proper position of the capacitors (A1A10C1 and A1A10C4). See Figure 1.

Any HP 85662A IF-Display Section within the above serial range should be inspected. If capacitors A1A10C1 and A1A10C4 are found to be installed in the wrong location, replace both capacitors with new ones using the following procedure.

5. Remove the 2 screws securing the bracket over the top of the capacitors and remove the bracket.
6. Remove the 2 rear feet near the bottom of the IF-Display Section.
7. Remove the bottom cover.

8. Remove the 4 screws securing A1A10C1 and A1A10C4 to the motherboard.
9. Remove the existing capacitors and replace with new capacitors, making sure the A1A10C1, 22000 μ F (HP part number 0180-2808), and A1A10C4, 8700 μ F (HP part number 0180-0453), are in the correct locations.
10. Reinstall the bracket, top cover, bottom cover, and the 4 rear feet.
11. Mate the IF and RF sections and reconnect cables. No calibration is required.
