86030A-04

S E R V I C E N O T E

86030A 50GHz Lightwave Component Analyzer

HDD Recovery Procedure for 86030A 4U System Controllers (P/N 86030-80019) configured with PCI-GPIB+ Cards

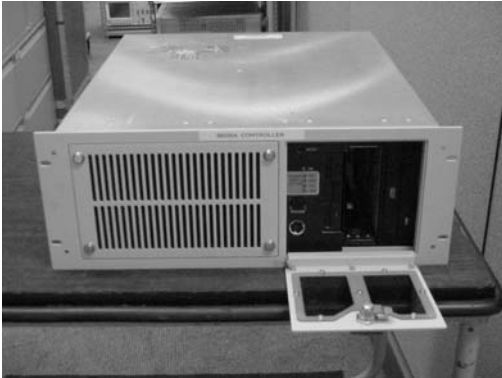
Figure 1 – (“New” 2003) 4U System Controller (P/N 86030-80019)

After performing a HDD recovery on a new 86030A 4U System Controller (P/N 86030-80019, see Figure 1), you may be required to change the GPIB card configuration.

- configured with PCI-GPIB+ card and Aviant Motherboard.
- Recover HDD with PN:86030-10002 Aviant Recovery Disk followed by GPIB Configuration setup.

After having used the recovery disk (PN:86030-10002 Aviant Recovery Disk) and observing the above symptoms, run the Software Configuration wizard and select board type "PCI-GPIB+".

1. Launch the NI "**Measurement and Automation**" program from the desktop.
2. Under **Devices and Interfaces**, right-click **GPIB0 (PCI-GPIB)**.
3. Select **NI 488.2 Getting Started Wizard**.
4. Select **Configure Your GPIB Interface -> Next**.
5. Follow the directions and configure GPIB0 for **Board Type = PCI-GPIB+**
6. Start the 86030A Main software.

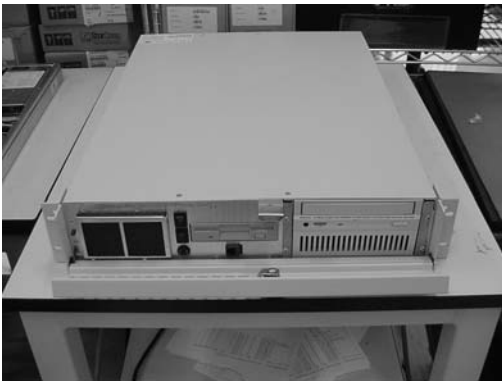
Figure 2 – 2U System Controller with front panel open (86030-80011 - discontinued)

- configured with PCI-GPIB card and Aviant or Endeavor+ Motherboard.
- Recover HDD with EITHER PN:86030-10002 Aviant Recovery Disk or PN 86030-10007 Endeavor+ Recovery Disk, as appropriate based on motherboard.

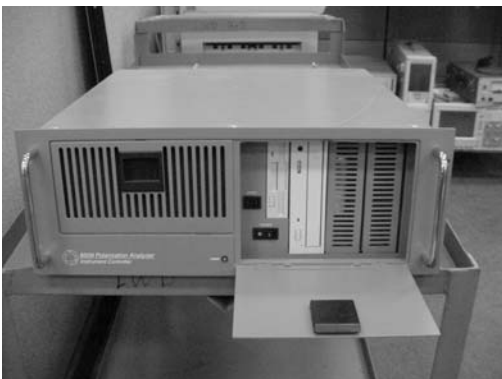
Figure 3 – (“Old” pre-2002) 4U System Controller (“Boxcar Willie”, army green in color, discontinued)

- configured with PCI-GPIB card and Motherboard has AMD K6 Processor.
- Recover HDD with PN 86030-10006 4U Recovery Disk.
