S E R V I C E N O T E

HP 8751A Network Analyzer

Serial Numbers: 0000J00000/3146J00701
 0000A00000/xxxxAxxxxx (To be advised later)
 (Firmware Revision 4.01 and below)

Firmware upgrade improves performance and corrects known problems described in Table 1.

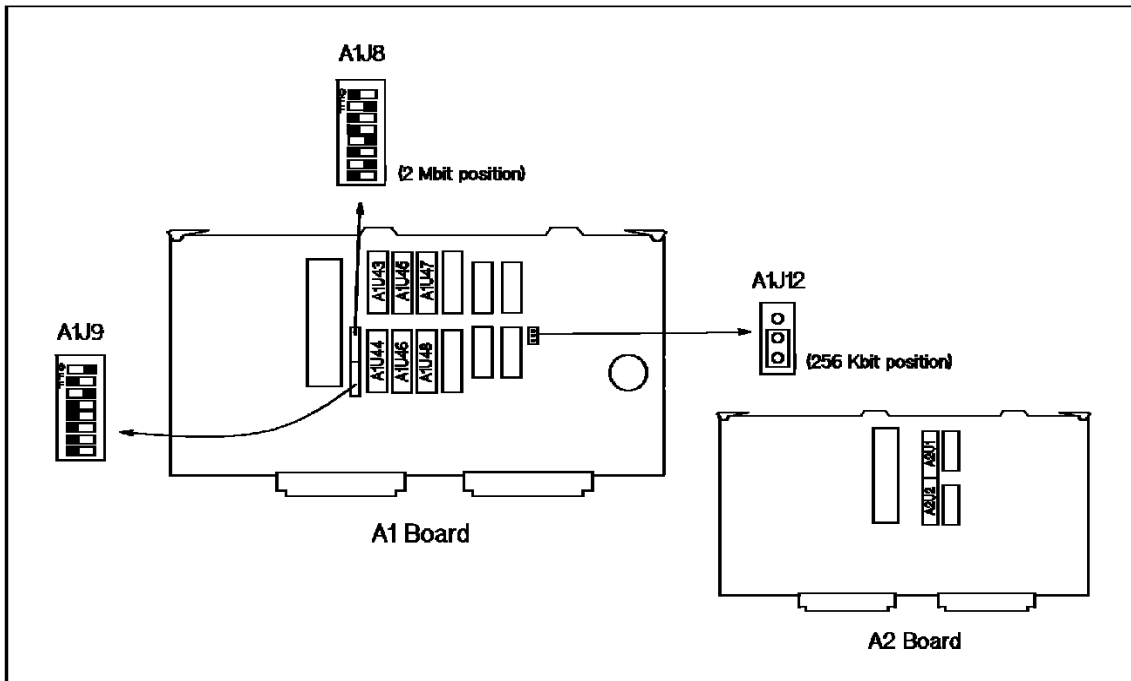
Figure 1. A1 and A2 Boards

- a. Remove only the A1 board.
 - b. Replace the ROMs of the A1 board with Rev.4.02 ROMs. Table 2 and Figure 1 show the ROM locations.
4. If the revision is "Rev.3.xx" and below,

- c. Figure 1 shows the jumper and bit switch settings for Rev. 4.02. In case of any difference, replace RAMs and change the switch settings by referring to the Modification Note (P/N 08751-90034).

- a. Remove the A1 and A2 boards.
 - b. Replace the ROMs of the A1 and A2 boards with Rev. 4.02 ROMs. The ROM locations are shown in Table 2, Table 3 and Figure 1.

Reference Designator	Part Number W/O Opt.002	Part Number W/ Opt.002
A1U43	08751-85901	08751-85611
A1U44	08751-85902	08751-85612
A1U45	08751-85903	08751-85613
A1U46	08751-85904	08751-85614
A1U47	N/A	08751-85615
A1U48	N/A	08751-85616

Reference Designator	Part Number
A2U1	08751-85421
A2U2	08751-85422
