S E R V I C E N O T E

89410A Vector Signal Analyzer**Serial Numbers:** See text for all applicable serial numbers.**Calibration failures caused by ADC shorting to heat sink****Duplicate Service Notes:** 89410A-03, 89440A-03**To Be Performed By:** Agilent-Qualified Personnel**Parts Required:**

DATE: 01 June 1993

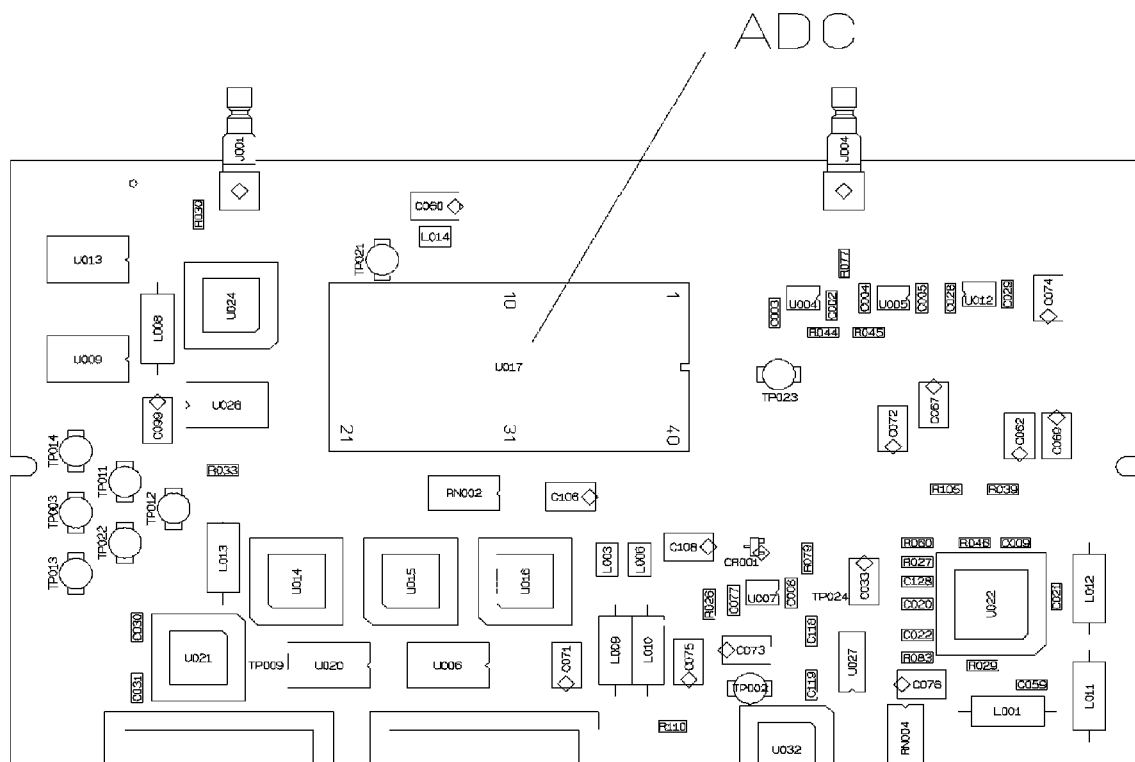
Figure 1

Analyzers with an IF section serial number less than 3313A00220 may have calibration failures caused by the IF section's ADC shorting to its bottom heat sink. To solve this problem, an insulator needs to be placed between the A20 U17 ADC and its bottom heat sink.

STEP 2. Install the silpad under A20 U17.

1. Remove the heat sink on top of A20 U17 using a T-8 Torx screw driver.
2. Remove A20 U17 from its socket.
3. Place the silpad on the bottom of A20 U17.
4. Install A20 U17 in its socket and replace the top heat sink.
