S E R V I C E N O T E

89430A RF Section

Sharp Metal Edge Shorting Power Supply Cable**To Be Performed By:** Agilent-Qualified Personnel**Duplicate Service Notes:** None**Parts Required:**

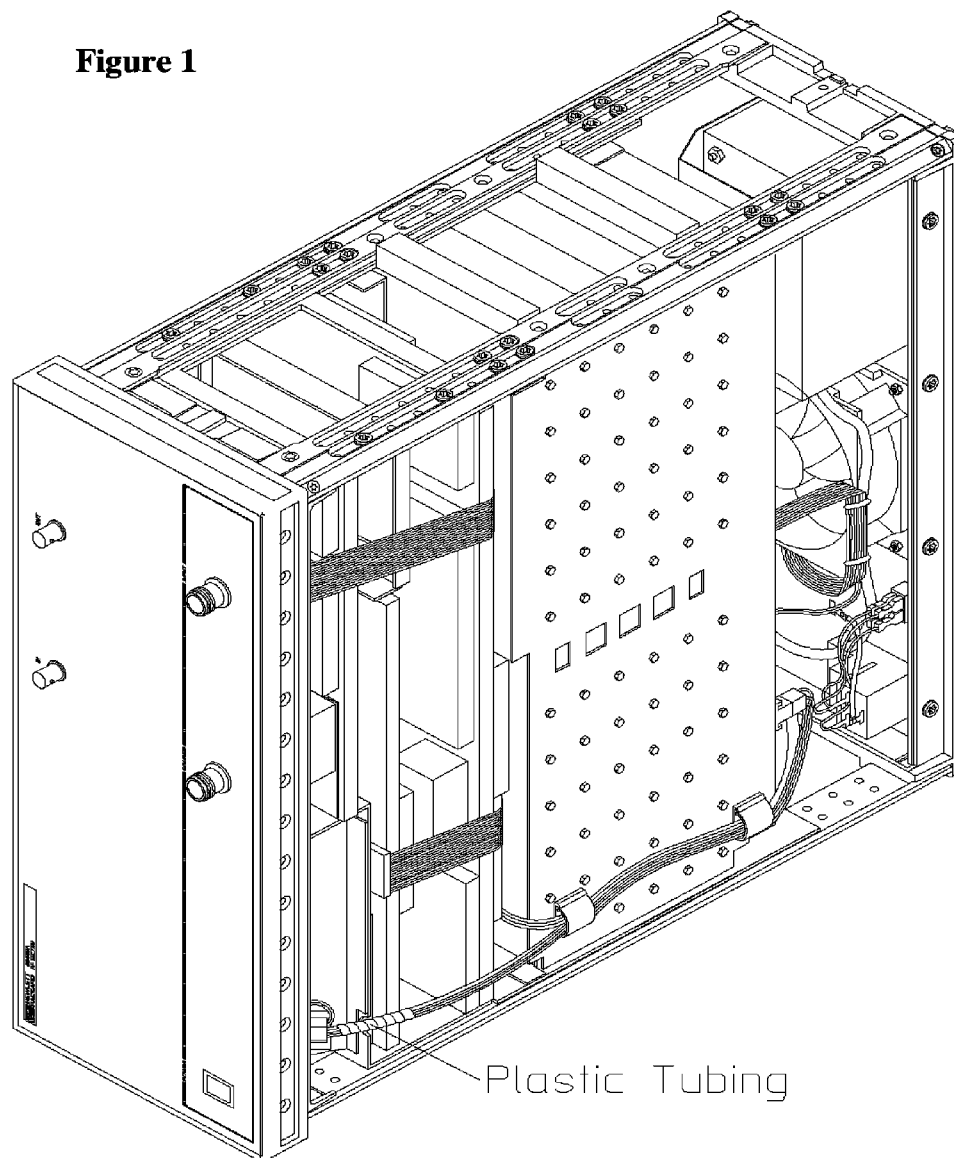
Figure 1

The insulation on a wire in a bundle of cables may be damaged by a sharp metal edge resulting in a power supply short.

STEP 2: Place the spiral plastic tubing over the bundle of cables which cross the A99 Motherboard and the sheet metal bracket MP111. See Figure 1.

If any of the cables are damaged, see chapter 7, “Replacing Parts” in the 89440A Service Guide for replacement information.
