8990B-03

Modification Recommended Service Note

8990B-Peak Power Analyzer

Peak Power Analyzer shuts off for no apparent reason

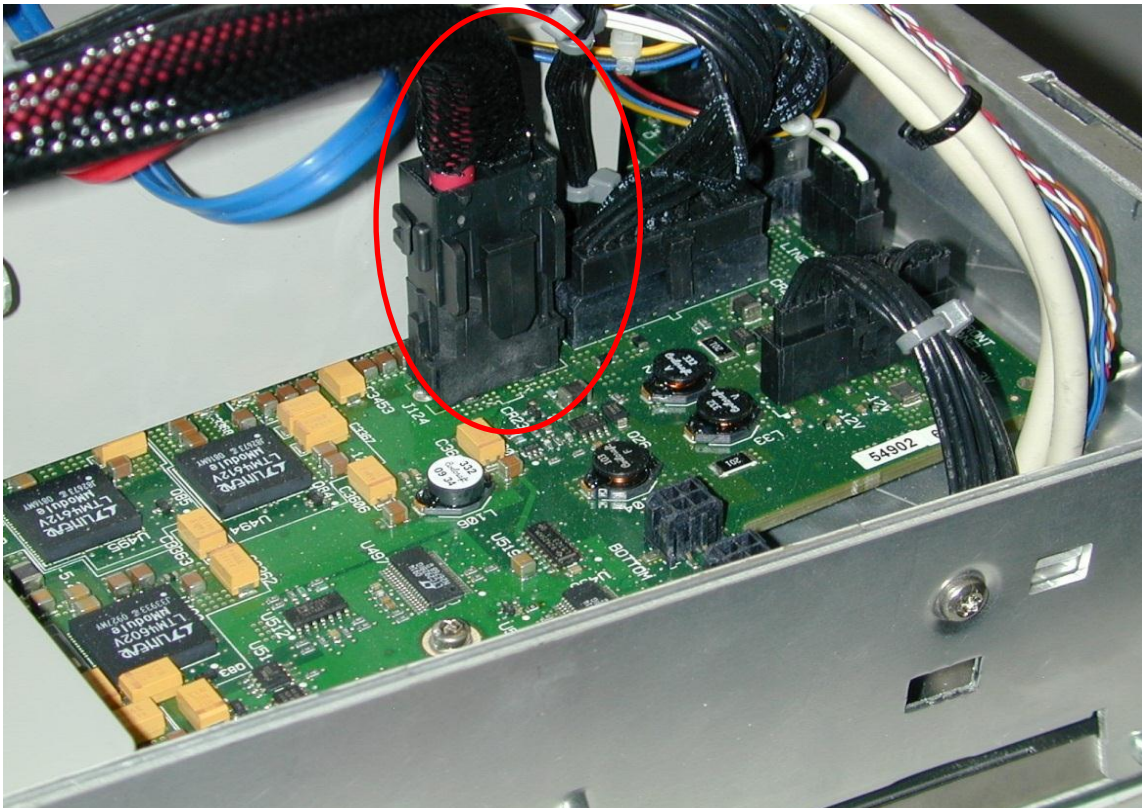
It has been determined that the short-term, power-on, in-rush current on the +12V bulk power cable can exceed 100 amps. This exceeds the design specification of the bulk power connector, which is rated at 50 amps max. After numerous power cycles, it has been found that the material on +12V terminal becomes corroded, leading to an increase in the resistance of this terminal. As this resistance increases, a voltage drop appears across the terminal. This voltage drop reduces the voltage that appears at the +12V monitoring circuit. When the voltage appearing at the monitoring circuit drops sufficiently, it trips the low-voltage sense which, in turn, powers down the scope.

1. Visually inspect the contacts of the acquisition board (connector J124) and bulk power cable verifying that they are silver in color. If they are gold, contact support at csg.support@keysight.com . If silver, proceed to step 2.
2. Make sure that the new acquisition board has the gold contacts as the part numbers are the same as the older with silver contact ones.
3. Remove the power cable and acquisition board.
4. Replace the 3 above mentioned parts following the replacement procedures for the acquisition board as stated in the Service Manual.

We will not support any attempt to clean the +12V power cable connector terminals.
