DSA90404A-06**S E R V I C E N O T E**Supersedes:
NONE**DSA90404A Infiniium High Performance Oscilloscope:
4GHz**

Serial Numbers: MY00000000 up to MY49470100 and SG00000000 up to SG49470100

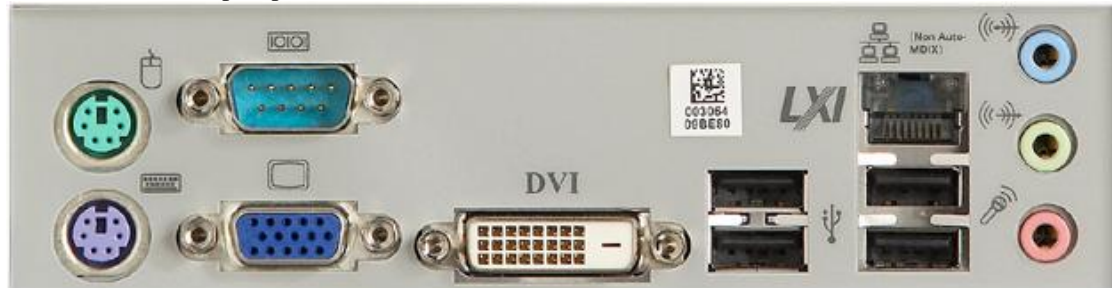
M890 Motherboard port panel.

The easiest way to recognize the M880 motherboard from the M890 motherboard is the White DVI connector on the motherboard port panel. If the motherboard has this white DVI connector it is a M890 motherboard.
