**DSA90604A-06****S E R V I C E N O T E**Supersedes:  
NONE**DSA90604A Infiniium High Performance Oscilloscope:  
6GHz**

Serial Numbers: MY00000000 up to MY49470100 and SG00000000 up to SG49470100

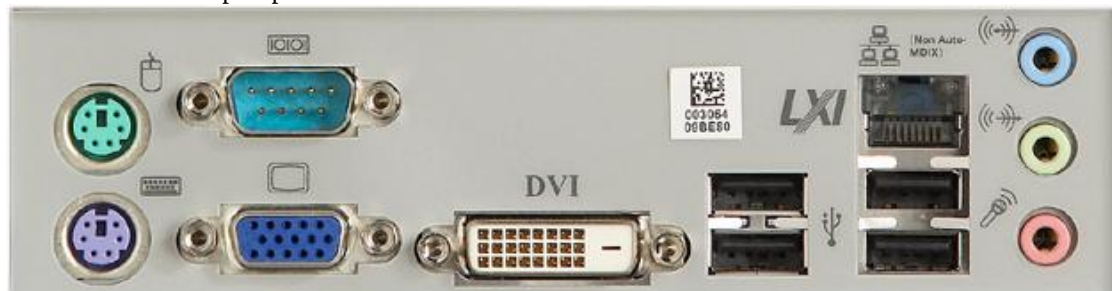
The easiest way to recognize the M880 motherboard from the M890 motherboard is the White DVI connector on the motherboard port panel. If the motherboard has this white DVI connector it is a M890 motherboard.

M890 Motherboard port panel.

The repair is to replace the M880 motherboard and SATA cables, using the M880 Motherboard Replacement Kit, part number 54913-68719.
