DSA91204A-06A

S E R V I C E N O T E

DSA91204A Infiniium High Performance Oscilloscope: 12GHz

Serial Numbers: MY00000000 up to MY49470100 and SG00000000 up to SG49470100

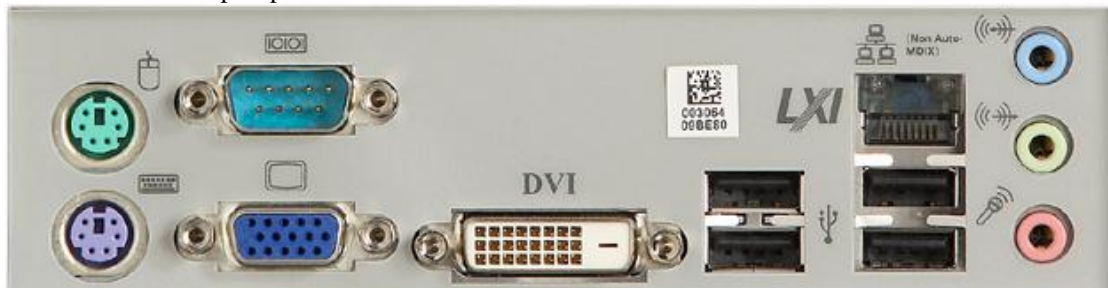
The easiest way to recognize the M880 motherboard from the M890 motherboard is the White DVI connector on the motherboard port panel. If the motherboard has this white DVI connector it is a M890 motherboard.

M890 Motherboard port panel.

If there already is a M890 motherboard installed then this is NOT covered per this service note. If the Serial # is > than the listed range then troubleshoot and handle as normal processes and procedures. It is not covered by this service note.
