# DSAX91604A-03

### DSAX91604A 16GHz Digitizing Oscilloscope

Serial Numbers: MY00000000 up to and including MY50270123

Front panel connector may not offer a good ground connection for probes

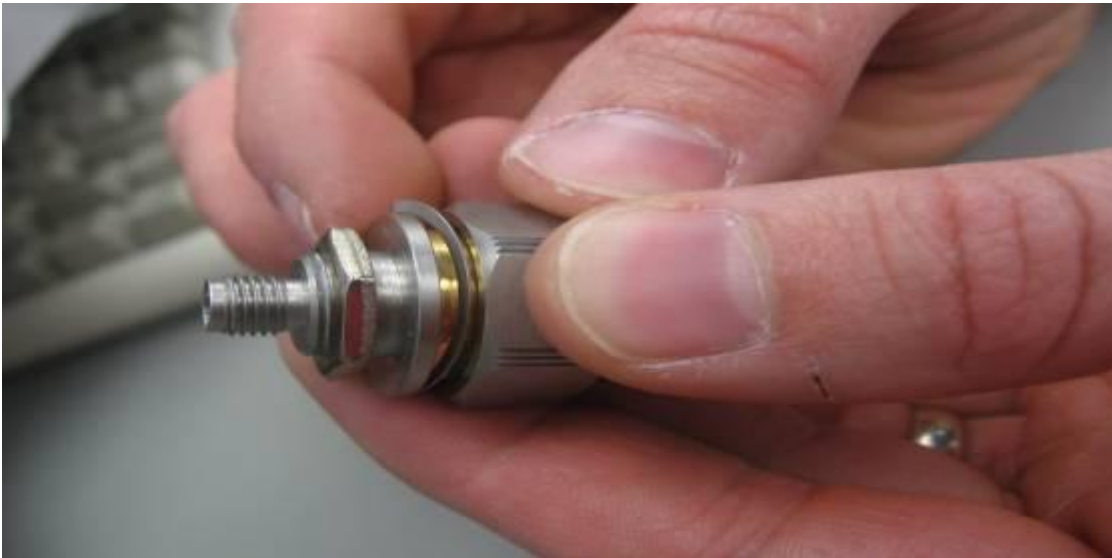
The front panel connector may not provide an adequate ground for N280XA probe amps. You may see more trace noise than you would expect.

You do not need to disassemble the covers from the instrument. If the scope was recently repaired, it is possible the fix was already implemented. You can lightly tap on the outer gray clutch that surrounds the channel input connectors. The clutch will move in a couple of millimeters. If the spring was installed, it should pop back out. Also, if you look carefully, you may see the spring on the input connector. Below is a picture from production showing the spring installed before the front panel connector is installed in the scope. You do not need to remove the front panel connector to install the spring.

Read the entire procedure before starting so you fully understand the process. Some of the pictures are from manufacturing. You do not need to disassemble the scope for this repair.
