DSAX92504A-03

S E R V I C E N O T E

DSAX92504A 25GHz Digitizing Oscilloscope

Front panel connector may not offer a good ground connection for probes

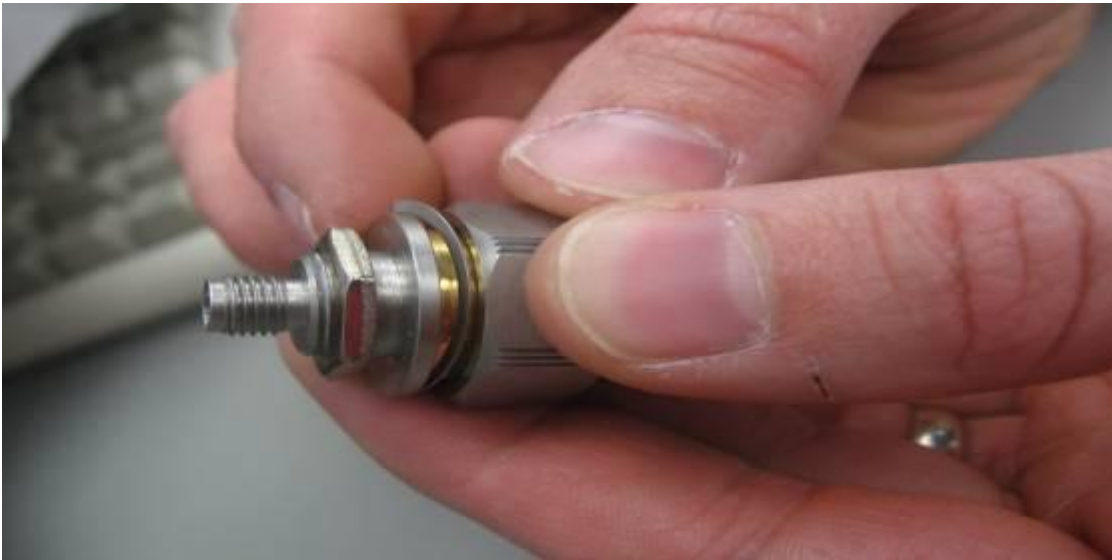
The front panel connector may not provide an adequate ground for N280XA probe amps. You may see more trace noise than you would expect.

You do not need to disassemble the covers from the instrument. If the scope was recently repaired, it is possible the fix was already implemented. You can lightly tap on the outer gray clutch that surrounds the channel input connectors. The clutch will move in a couple of millimeters. If the spring was installed, it should pop back out. Also, if you look carefully, you may see the spring on the input connector. Below is a picture from production showing the spring installed before the front panel connector is installed in the scope. You do not need to remove the front panel connector to install the spring.
