DSO90254A-06A

S E R V I C E N O T E

DSO90254A Infiniium High Performance Oscilloscope: 2.5GHz

Serial Numbers: MY00000000 up to MY49470100 and SG00000000 up to SG49470100

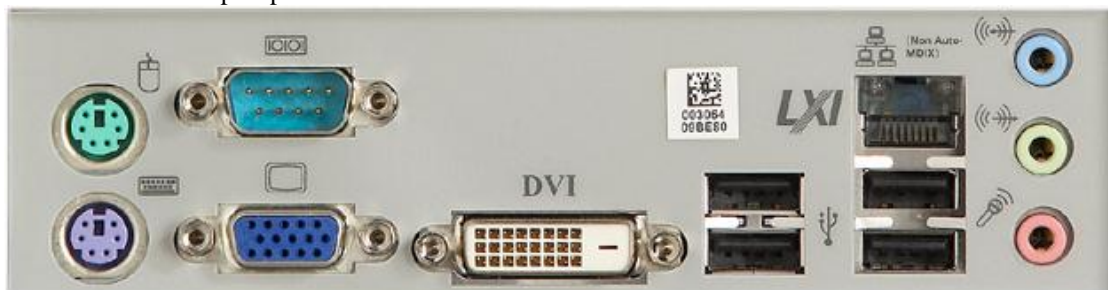
The easiest way to recognize the M880 motherboard from the M890 motherboard is the White DVI connector on the motherboard port panel. If the motherboard has this white DVI connector it is a M890 motherboard.

M890 Motherboard port panel.
