**DSO90404A-06****S E R V I C E N O T E**Supersedes:  
NONE**DSO90404A Infiniium High Performance Oscilloscope:  
4GHz**

Serial Numbers: MY00000000 up to MY49470100 and SG00000000 up to SG49470100

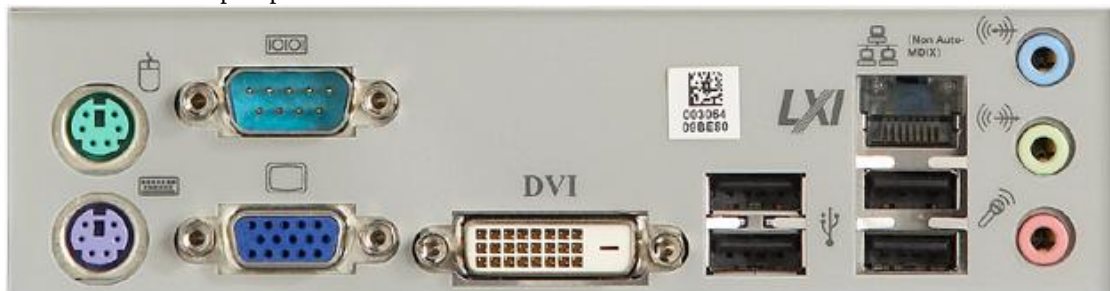
The easiest way to recognize the M880 motherboard from the M890 motherboard is the White DVI connector on the motherboard port panel. If the motherboard has this white DVI connector it is a M890 motherboard.

M890 Motherboard port panel.

The repair is to replace the M880 motherboard and SATA cables, using the M880 Motherboard Replacement Kit, part number 54913-68719.
