# DSO90404A-06A

## S E R V I C E N O T E

### DSO90404A Infiniium High Performance Oscilloscope: 4GHz

Serial Numbers: MY00000000 up to MY49470100 and SG00000000 up to SG49470100

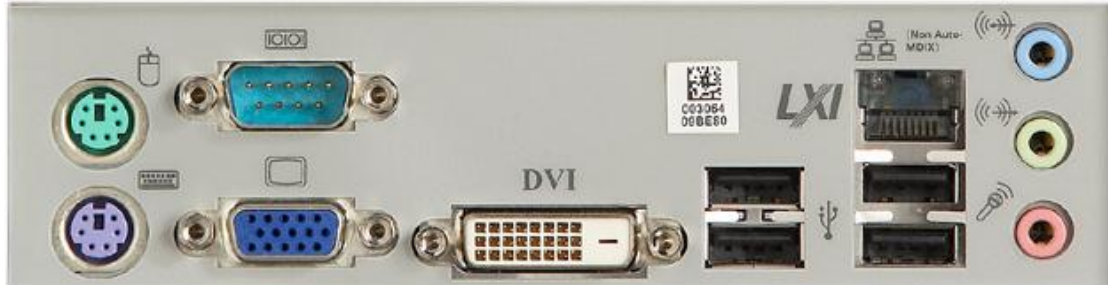
The easiest way to recognize the M880 motherboard from the M890 motherboard is the White DVI connector on the motherboard port panel. If the motherboard has this white DVI connector it is a M890 motherboard.

M890 Motherboard port panel.
