**DSO9064A-02**

# **S E R V I C E N O T E**

## **DSO9064A - 600MHz Digital Signal Oscilloscope**

### **Repair for Windows “Power surge on hub” message**

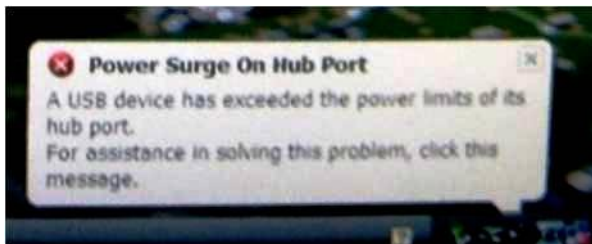
A few scopes display the below message. This upgrade kit installs three components which will resolve the problem and the message should disappear. If the message still appears, either the upgrade was done incorrectly or the motherboard is actually defective.

1. Refer to the service manual to remove the motherboard from the scope.
2. Install the three components from the upgrade kit on the motherboard. Refer to the below drawing and the drawing on the next page for component locations. The 0960-2789 motherboard is RoHS compliant and the below three components are also RoHS compliant. You should use a RoHS soldering station and RoHS solder techniques when possible.

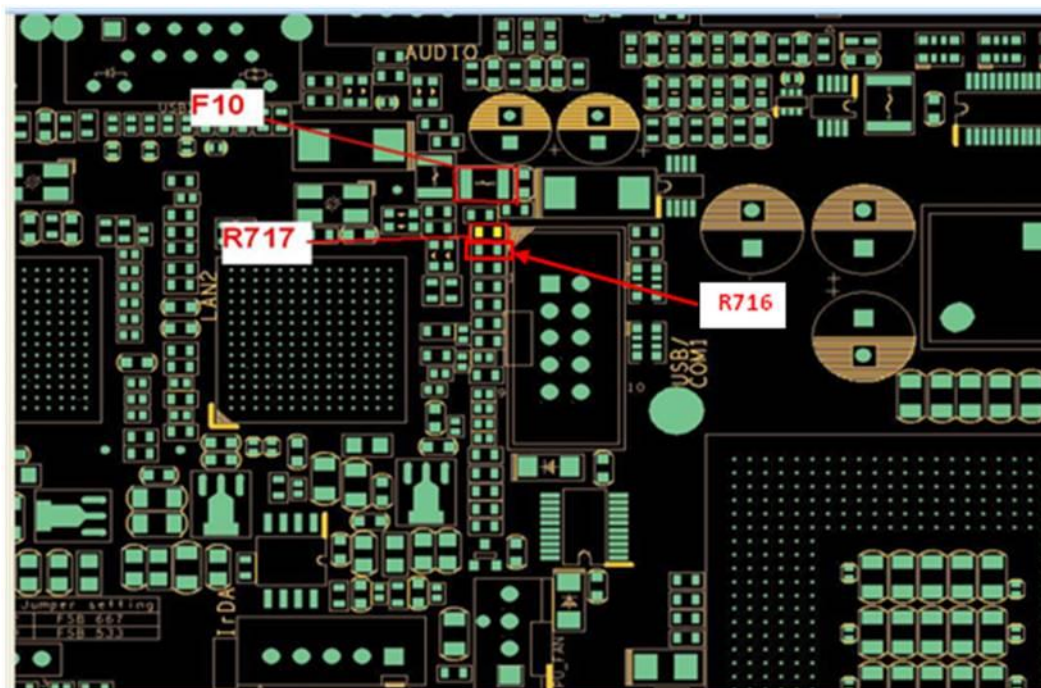
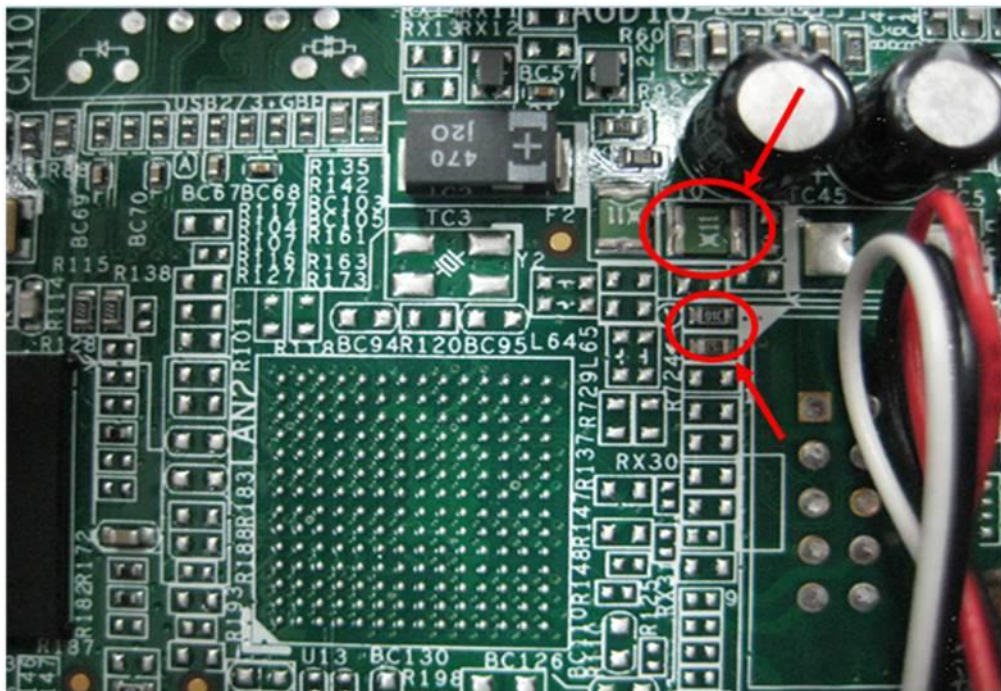
F10 – 0837-3854 Thermistor

R717 – 0699-7654 10K Resistor

R716 – 0699-5789 15K resistor

3. Install the motherboard back into the scope and install the covers.
4. The motherboard upgrade does not impact the self cal or the scope calibration.
5. Charge the cost of parts and labor to factory warranty. The motherboard changes do not impact the instrument calibration. But if you do perform a new calibration, you can charge that cost to factory warranty also.
