**DSO90804A-06****S E R V I C E N O T E**Supersedes:  
NONE**DSO90804A Infiniium High Performance Oscilloscope:  
8GHz**

Serial Numbers: MY00000000 up to MY49470100 and SG00000000 up to SG49470100

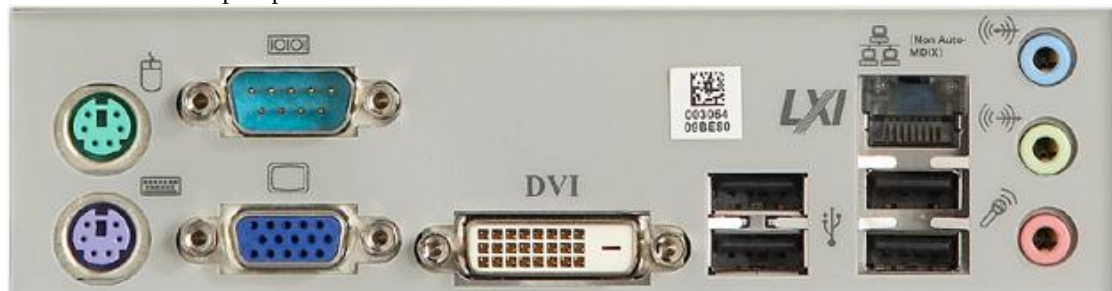
The easiest way to recognize the M880 motherboard from the M890 motherboard is the White DVI connector on the motherboard port panel. If the motherboard has this white DVI connector it is a M890 motherboard.

M890 Motherboard port panel.
