DSO9104A-03

S E R V I C E N O T E

DSO9104A - 1GHz Digital Signal Oscilloscope

Repair for Windows "Power surge on hub" message

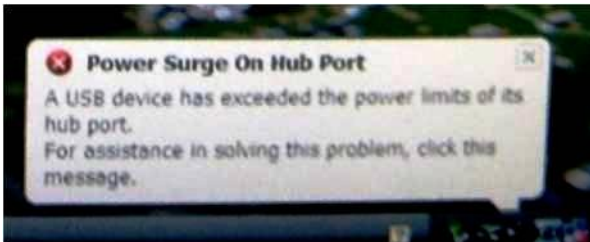
A few scopes display the below message. This upgrade kit installs three components which will resolve the problem and the message should disappear. If the message still appears, either the upgrade was done incorrectly or the motherboard is actually defective.

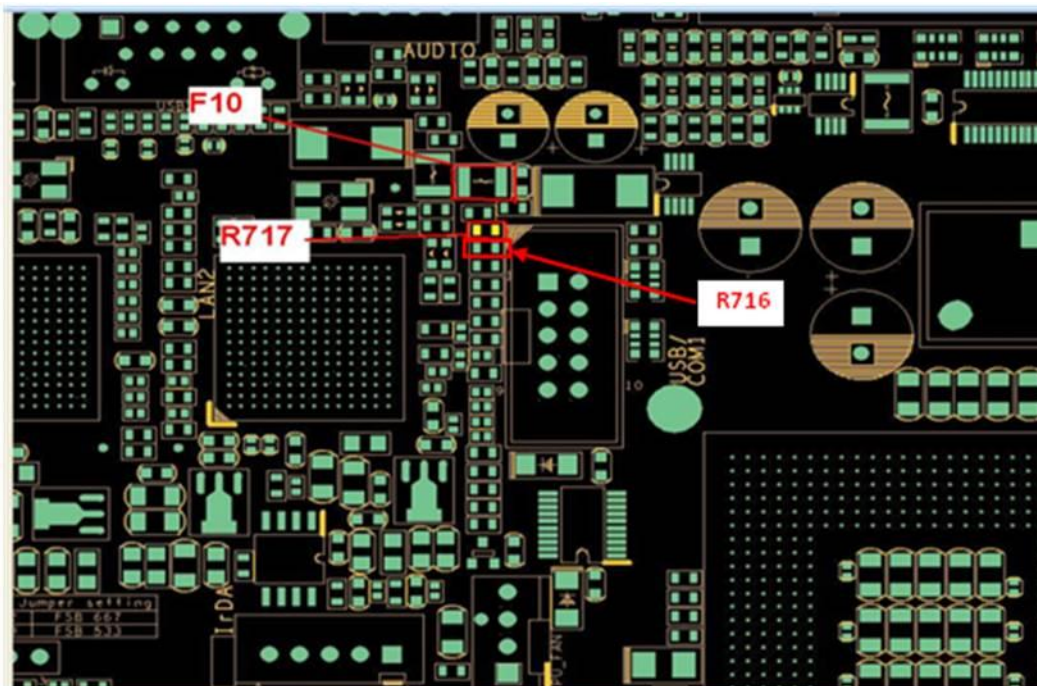
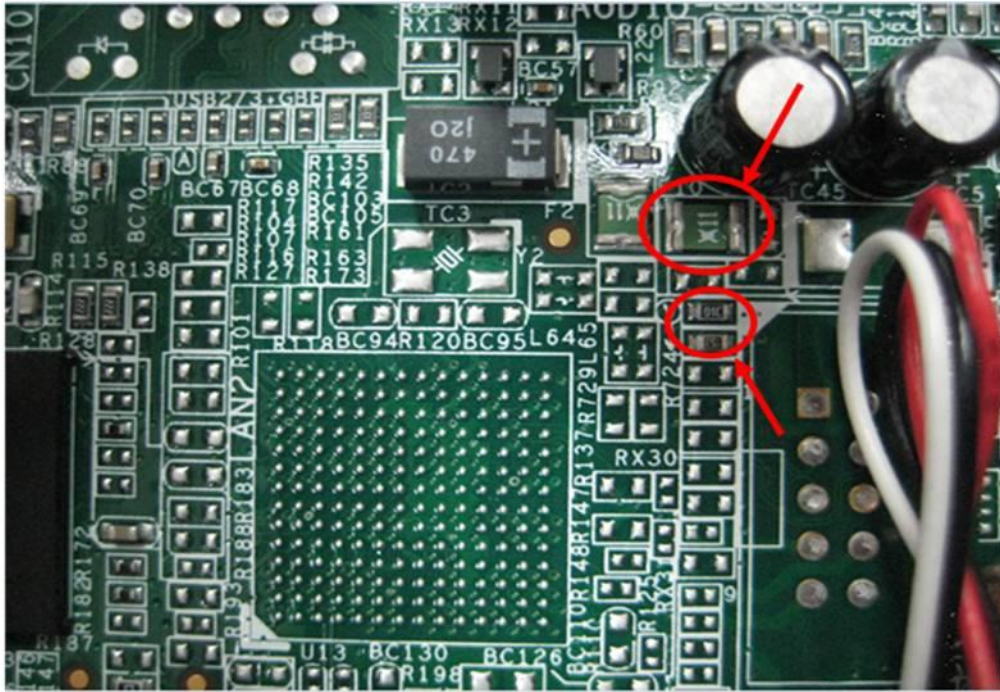
F10 – 0837-3854 Thermistor

R717 – 0699-7654 10K Resistor

R716 – 0699-5789 15K resistor

1. Refer to the service manual to remove the motherboard from the scope.
2. Install the three components from the upgrade kit on the motherboard. Refer to the below drawing and the drawing on the next page for component locations. The 0960-2789 motherboard is RoHS compliant and the below three components are also RoHS compliant. You should use a RoHS soldering station and RoHS solder techniques when possible.
