**DSO91204A-06****S E R V I C E N O T E**Supersedes:  
NONE**DSO91204A Infiniium High Performance Oscilloscope:  
12GHz**

Serial Numbers: MY00000000 up to MY49470100 and SG00000000 up to SG49470100

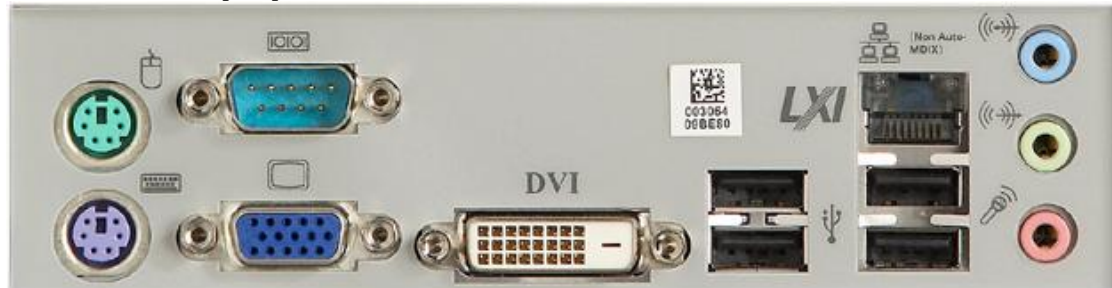
M890 Motherboard port panel.

The easiest way to recognize the M880 motherboard from the M890 motherboard is the White DVI connector on the motherboard port panel. If the motherboard has this white DVI connector it is a M890 motherboard.
