**DSO91304A-06****S E R V I C E N O T E**Supersedes:  
NONE**DSO91304A Infiniium High Performance Oscilloscope:  
13GHz**

Serial Numbers: MY00000000 up to MY49470100 and SG00000000 up to SG49470100

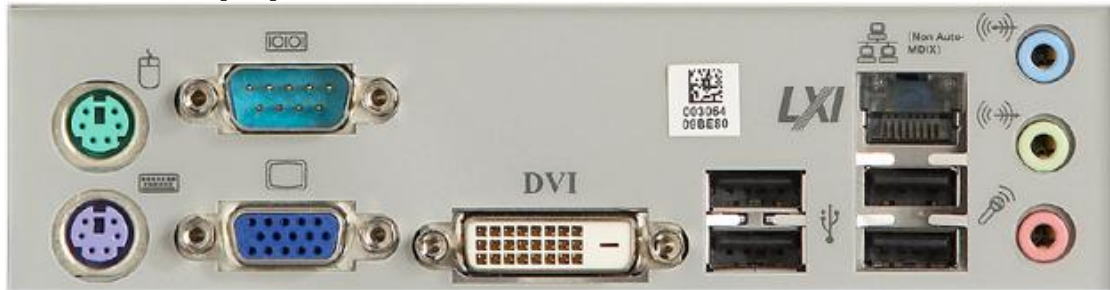
The easiest way to recognize the M880 motherboard from the M890 motherboard is the White DVI connector on the motherboard port panel. If the motherboard has this white DVI connector it is a M890 motherboard.

M890 Motherboard port panel.
