DSO91304A-06A

S E R V I C E N O T E

DSO91304A Infiniium High Performance Oscilloscope: 13GHz

Serial Numbers: MY00000000 up to MY49470100 and SG00000000 up to SG49470100

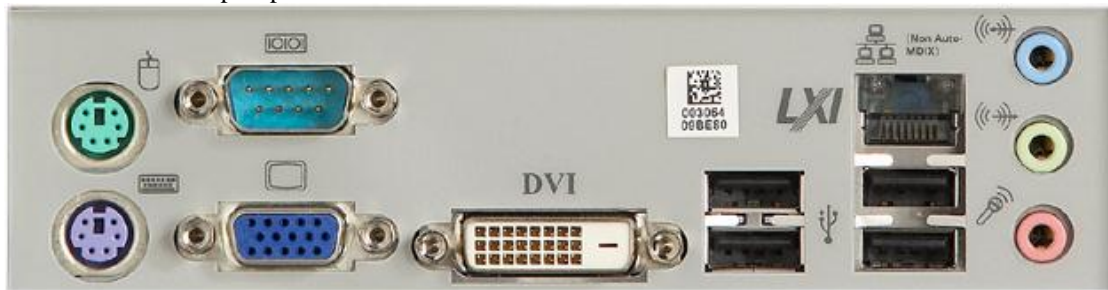
M890 Motherboard port panel.

The easiest way to recognize the M880 motherboard from the M890 motherboard is the White DVI connector on the motherboard port panel. If the motherboard has this white DVI connector it is a M890 motherboard.

If there already is a M890 motherboard installed then this is NOT covered per this service note. If the Serial # is > than the listed range then troubleshoot and handle as normal processes and procedures. It is not covered by this service note.
