DSO9254A-01

S E R V I C E N O T E

DSO9254A 2.5GHz Digitizing Oscilloscope

Serial Numbers: MY49190101 and MY49190102

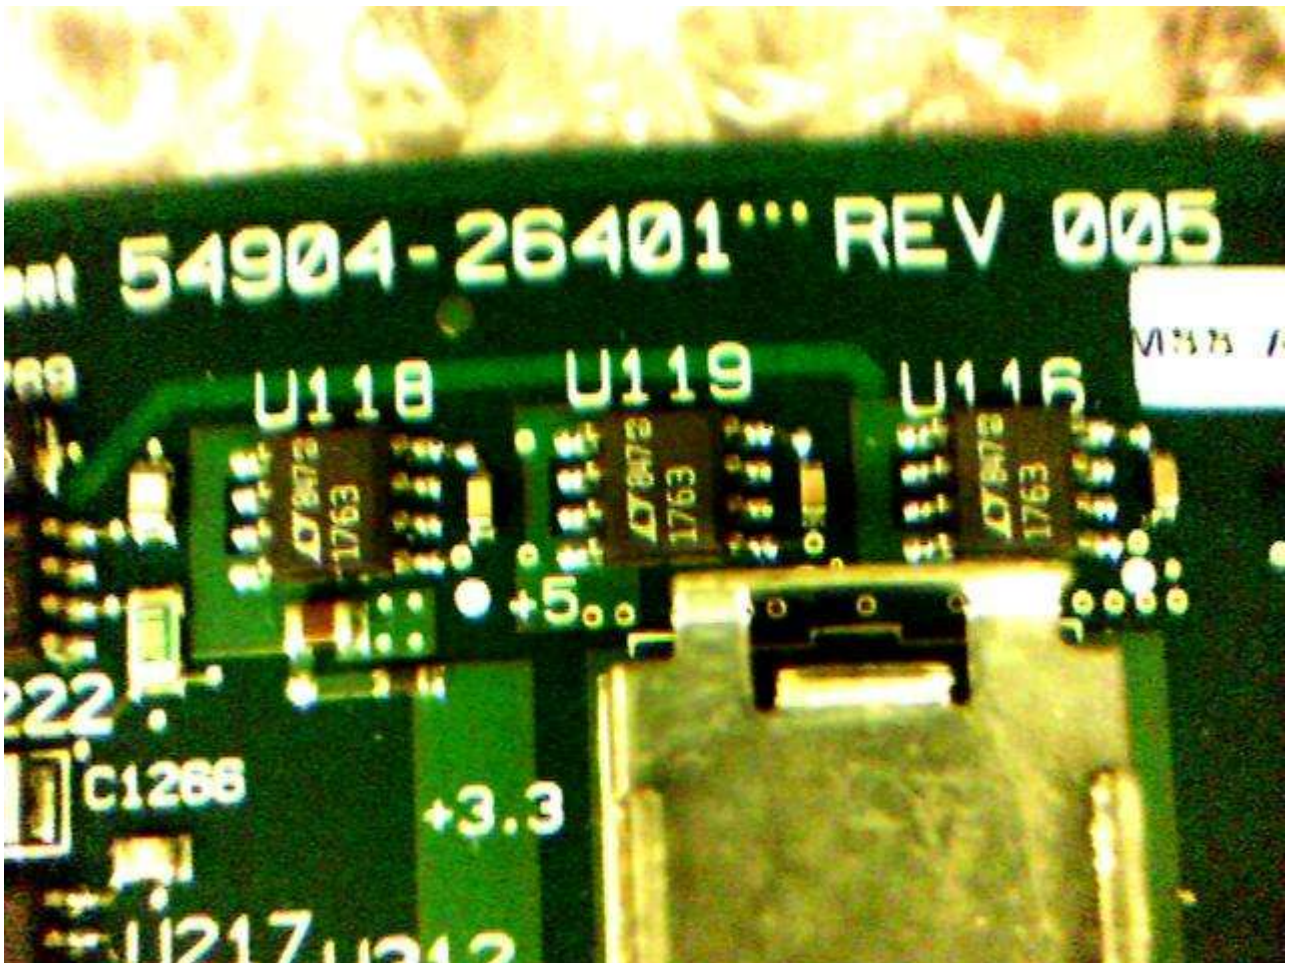
This is a onetime replacement because you are replacing the acquisition board 54901-66501 rev 005 with a later board rev of at least 006. The below picture shows a typical board number with the board rev listed. The board number 5490X-26401 is the raw PC board number. Once the board is loaded with parts and tested, the board number changes to 5490X-66501. The important part of the below picture is that the board rev of 005 is shown. This board must be removed from the scope and returned to SPO. SPO will return the defective board to AMC. You can install a new or refurbished acquisition board in the scope. At the writing of this service note, the new board part number was 54902-66501 and the refurbished part number was 54902-69501. If the board rev is 006 or higher, do not replace the acquisition board with this service note.

Refer to the 9000 series service manual for instructions to remove and replace the acquisition board. Perform the self calibration and self tests to make sure the replacement board is functioning correctly. Run final calibration on the scope and issue a new certificate of calibration. Charge the replacement acquisition board, labor, and calibration time to factory warranty.
