# DSO9404A-03

# S E R V I C E N O T E

## DSO9404A - 4GHz Digital Signal Oscilloscope

### Repair for Windows "Power surge on hub" message

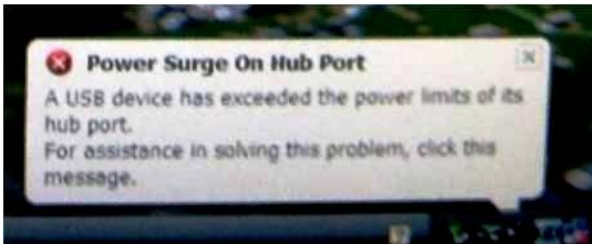
A few scopes display the below message. This upgrade kit installs three components which will resolve the problem and the message should disappear. If the message still appears, either the upgrade was done incorrectly or the motherboard is actually defective.
