Modification Recommended Service Note

DSOS054A – DSO Infiniium S Series 500MHz 4 channel

Serial Numbers: MY00000001 - MY58060101; SG54360101, SG54360102, SG55510101 to SG55510110; SG57200101, 58150101 to 58150104

The Problem – Under certain circumstances a PLL2 error may occur on the S-series products.

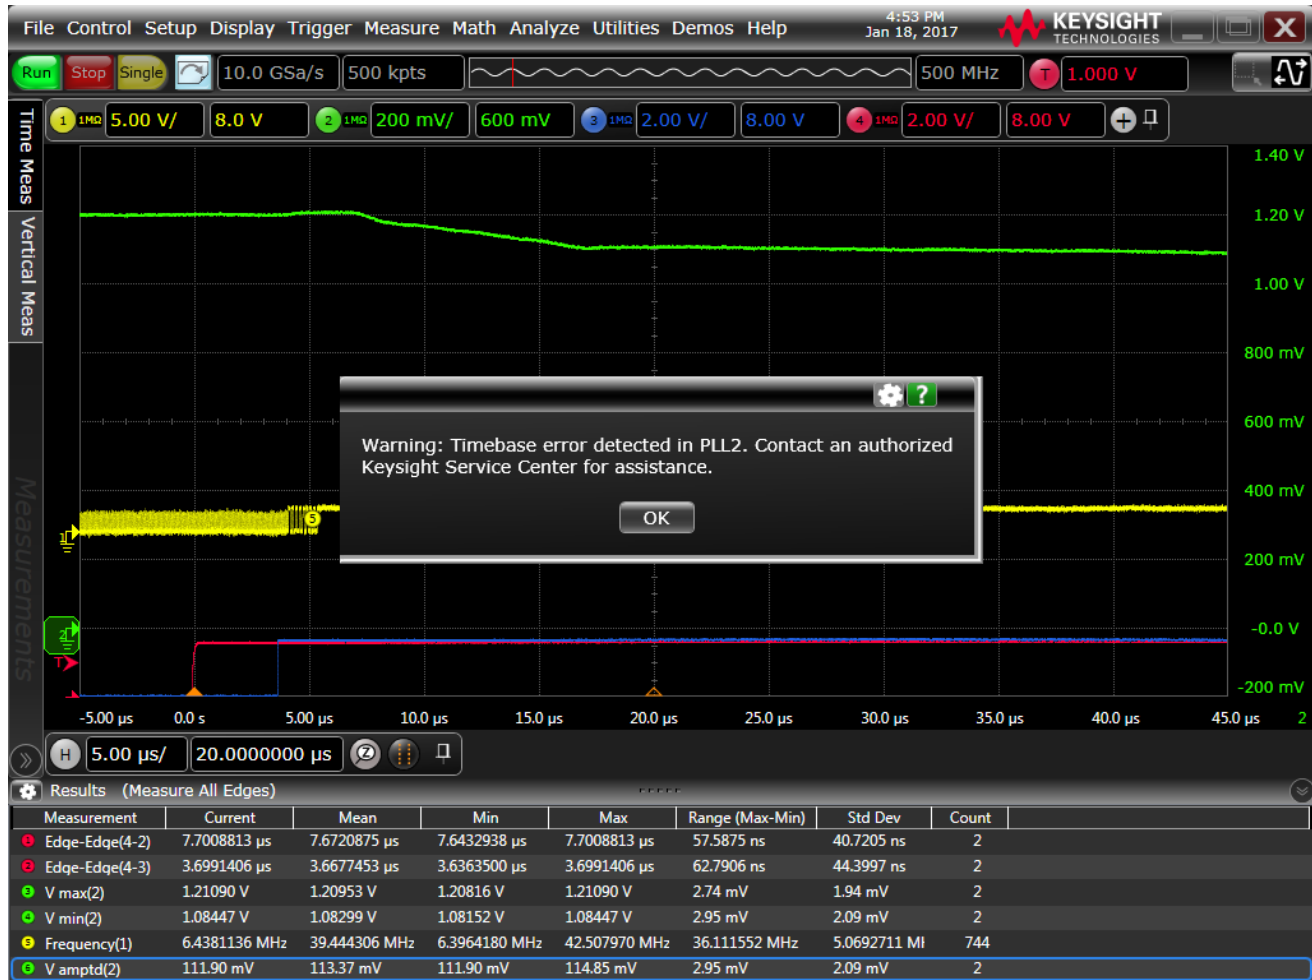
On older acquisition boards a PLL2 error message sometimes occurs. The error message appears on the screen as below:

There are new acquisition boards that fix this issue for the S-series scopes.

1. If the customer needs to have software revision < 6.10.01001, then replace the acquisition board with the 54911-69532 board.
2. If the customer can have software revision >= 6.10.01001, then it can be replaced by any of these three boards: 54911-69521, 54911-69531, or 54911-69532.
