Modification Recommended Service Note

DSOS104A – DSO Infiniium S Series 1GHz 4 channel

The Problem – Under certain circumstances a PLL2 error may occur on the S-series products.

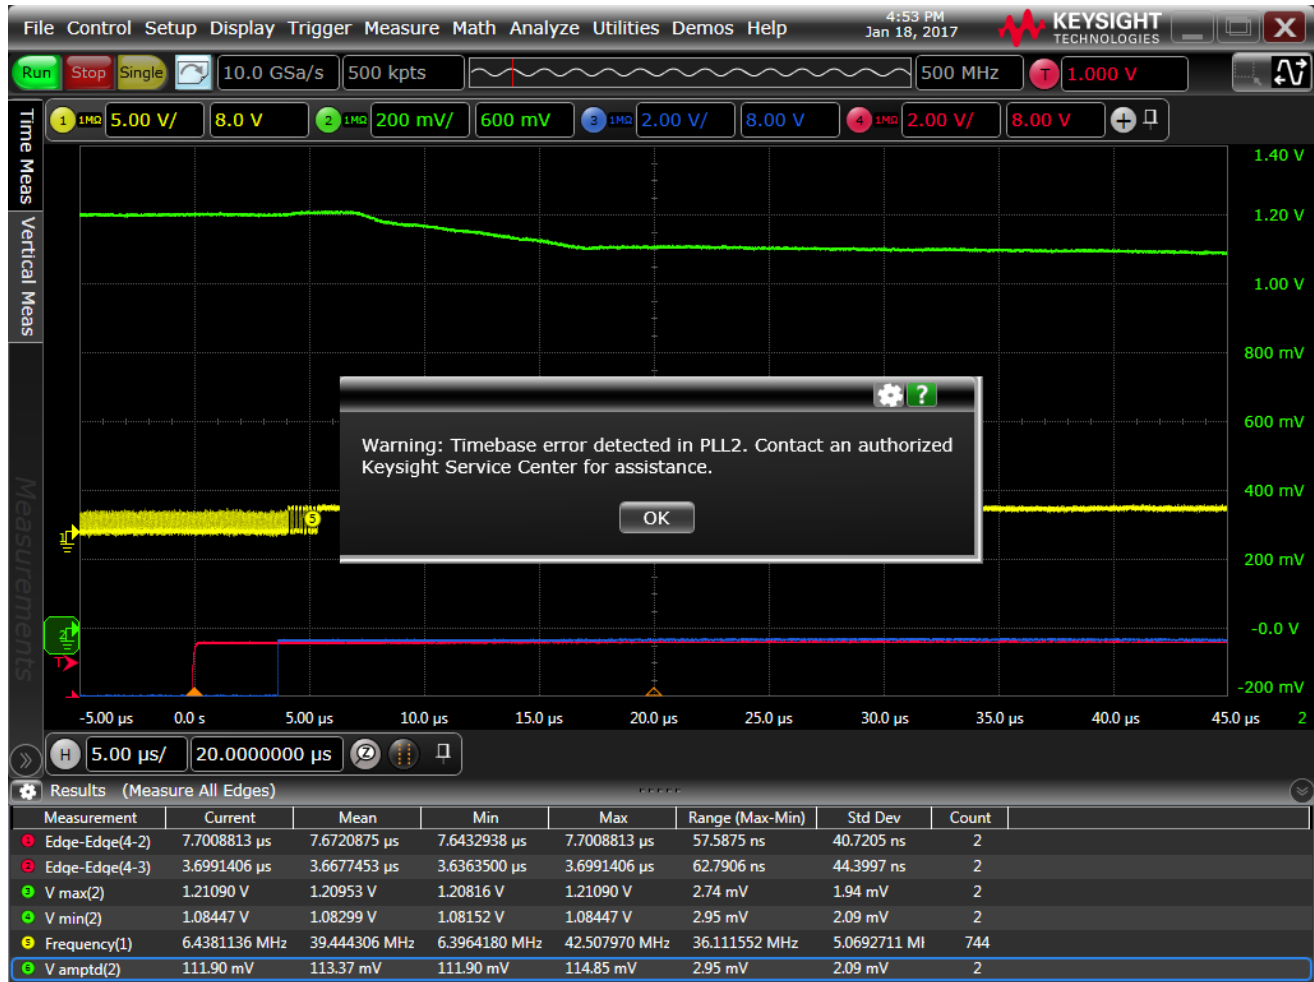
On older acquisition boards a PLL2 error message sometimes occurs. The error message appears on the screen as below:

There are new acquisition boards that fix this issue for the S-series scopes.

Please, use the 54911-69511 board until is gone.
If you have a 54911-69511, then skip steps 1 and 2 and proceed to step 3.
If there are no 54911-69511, then start with step 1 below.

1. If the customer needs to have software revision < 6.10.01001, then replace the acquisition board with the 54911-69532 board.
2. If the customer can have software revision \geq 6.10.01001, then it can be replaced by any of these three boards: 54911-69521, 54911-69531, or 54911-69532.
