Modification Recommended Service Note

DSOS104A – DSO Infiniium S Series 1GHz 4 channel

The Problem – Under certain circumstances a PLL2 error may occur on the S-series products.

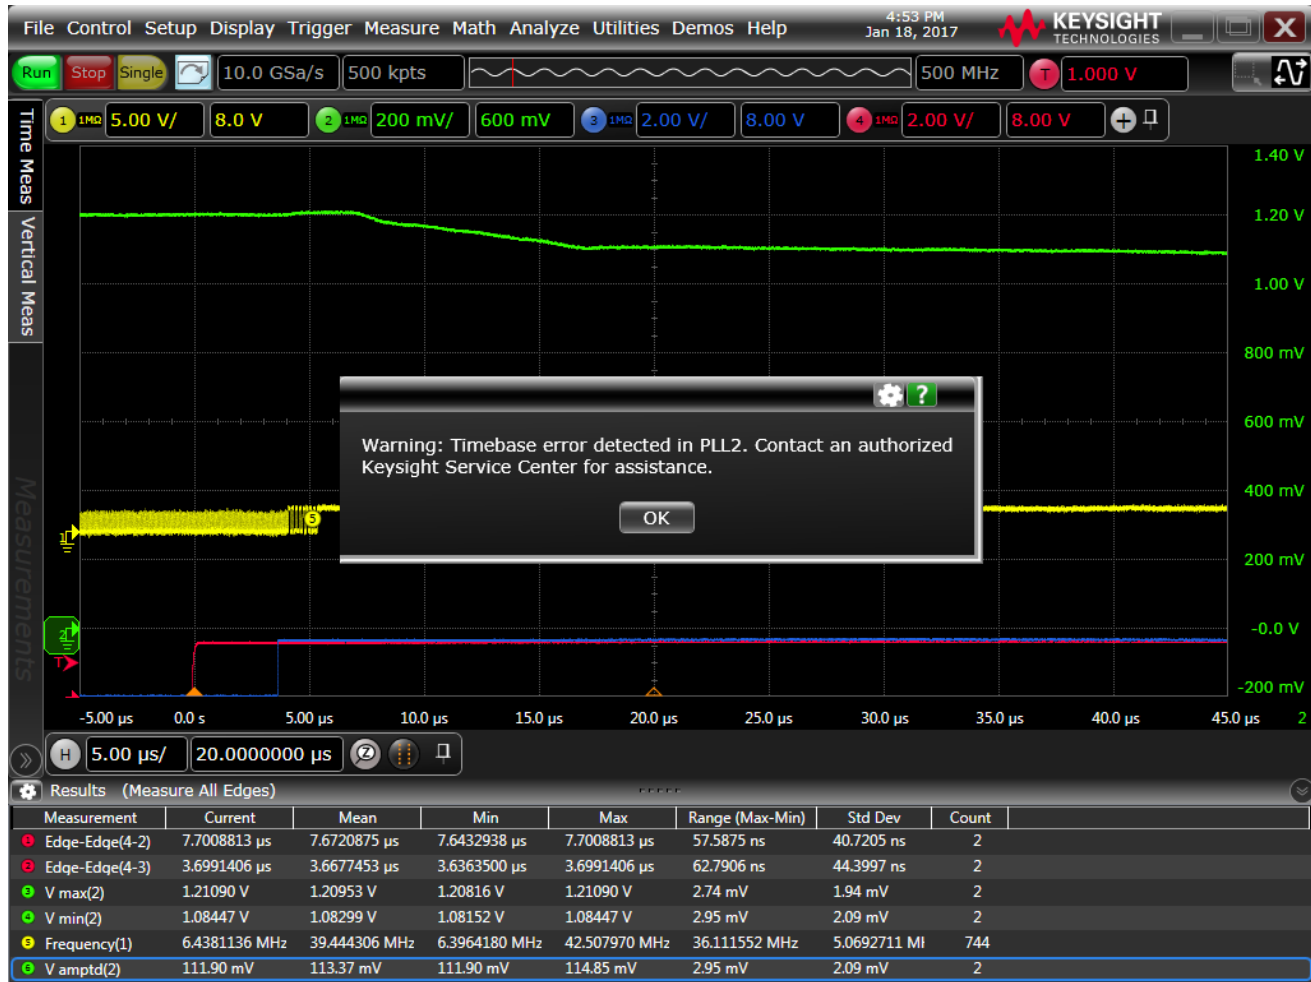
On older acquisition boards a PLL2 error message sometimes occurs. The error message appears on the screen as below:

There are new acquisition boards that fix this issue for the S-series scopes.

1. If the customer needs to have software revision < 6.10.01001, then replace the acquisition board with the 54911-69532 board.
2. If the customer can have software revision >= 6.10.01001, then it can be replaced by any of these three boards: 54911-69521, 54911-69531, or 54911-69532.
