Modification Recommended Service Note

Supersedes:
DSOS254A-03D

DSOS254A – DSO Infiniium S Series 2.5GHz 4 channel

Serial Numbers: MY00000001 - MY58060101; SG54360101, SG55160101, SG55300101, SG55380101, SG55510101 to SG55510112, SG58060101, SG58060102

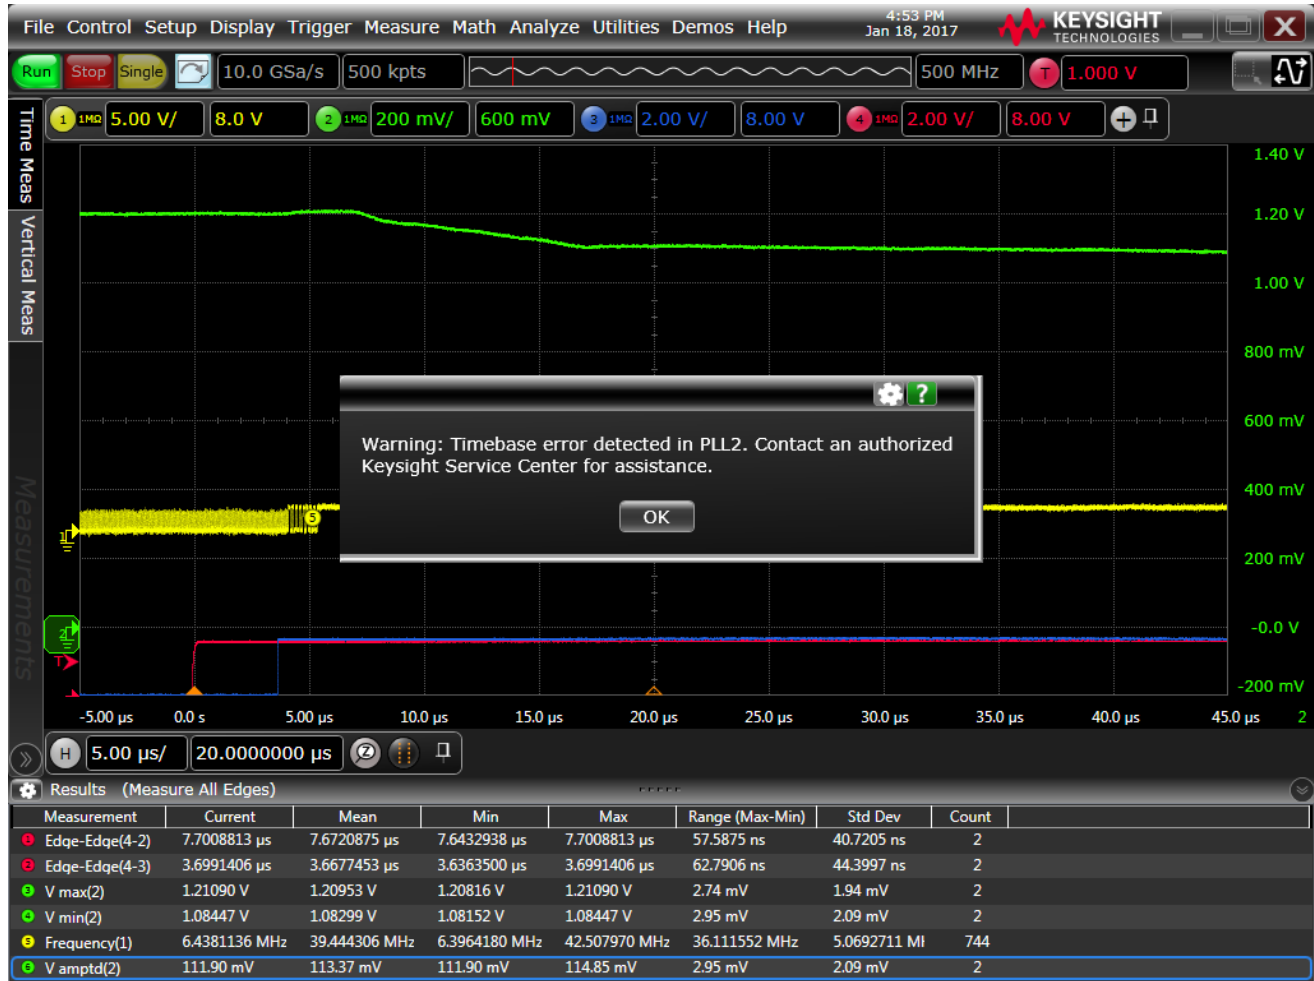
The Problem – Under certain circumstances a PLL2 error may occur on the S-series products.

On older acquisition boards a PLL2 error message sometimes occurs. The error message appears on the screen as below:

There are new acquisition boards that fix this issue for the S-series scopes.

Please, use the 54911-69511 board until is gone.

1. If the customer needs to have software revision < 6.10.01001, then replace the acquisition board with the 54911-69532 board.

2. If the customer can have software revision $\geq 6.10.01001$, then it can be replaced by any of these three boards: 54911-69521, 54911-69531, or 54911-69532.
3. Save the Serial Numbers of the replaced and the new Acquisition Boards in Siebel. Please, follow this procedure:
 - a. For each Service Order in Siebel, there is a tab labeled Activities:
