Modification Recommended Service Note

Supersedes:
DSOS254A-03E

DSOS254A – DSO Infiniium S Series 2.5GHz 4 channel

The Problem – Under certain circumstances a PLL2 error may occur on the S-series products.

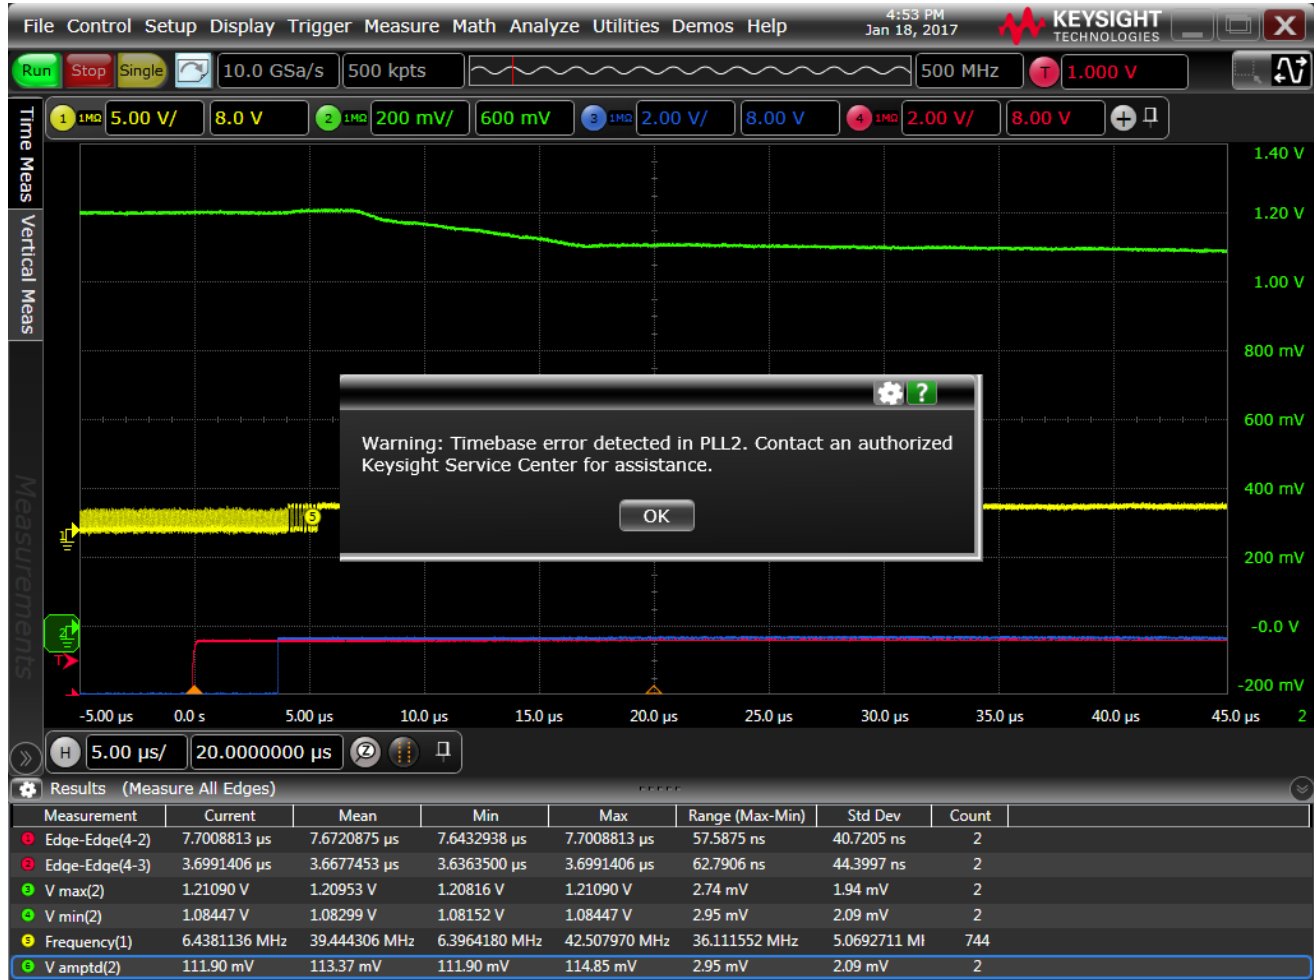
On older acquisition boards a PLL2 error message sometimes occurs. The error message appears on the screen as below:

There are new acquisition boards that fix this issue for the S-series scopes.

1. If the customer needs to have software revision < 6.10.01001, then replace the acquisition board with the 54911-69532 board.
2. If the customer can have software revision >= 6.10.01001, then it can be replaced by any of these three boards: 54911-69521, 54911-69531, or 54911-69532.
