# DSOX91604A-03

### DSOX91604A 16GHz Digitizing Oscilloscope

Serial Numbers: MY00000000 up to and including MY50270112

Front panel connector may not offer a good ground connection for probes

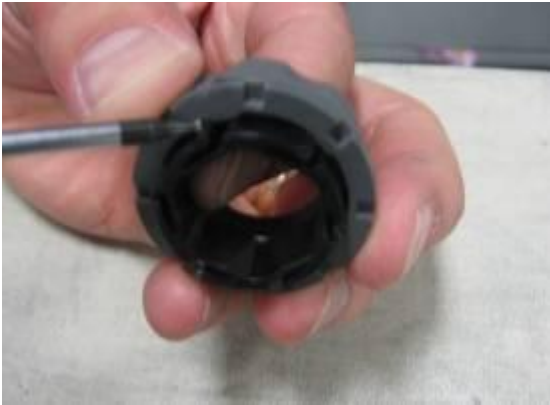
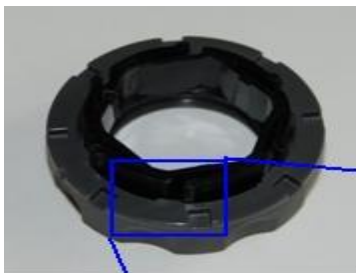
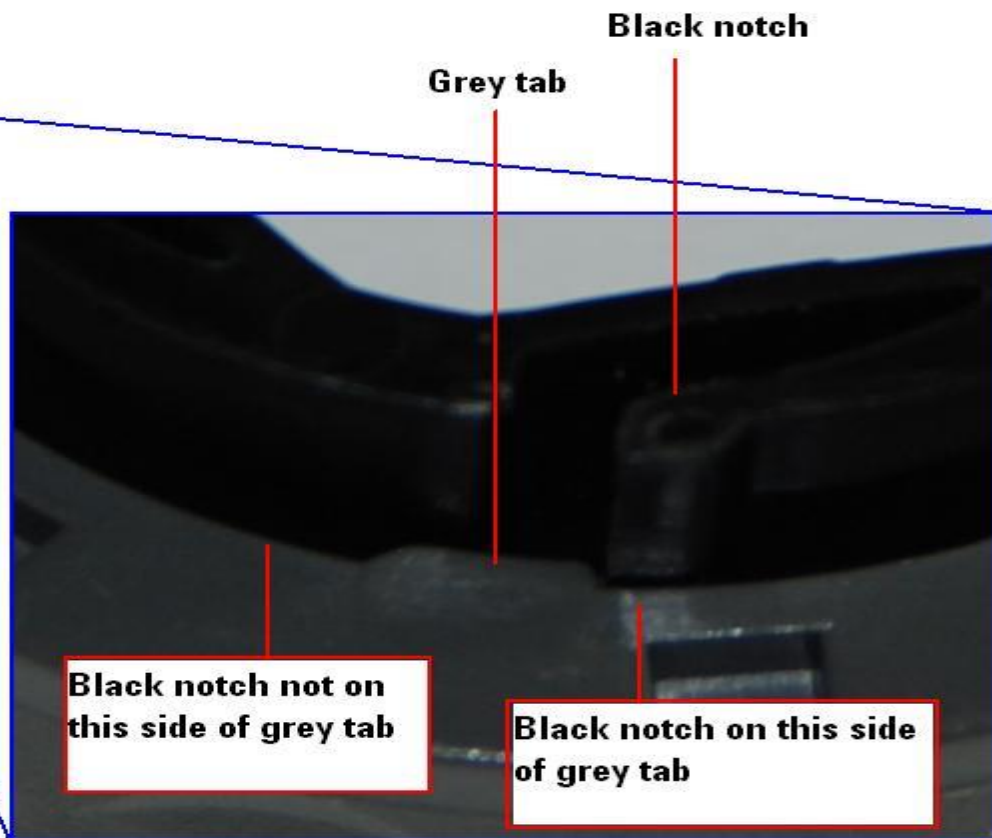
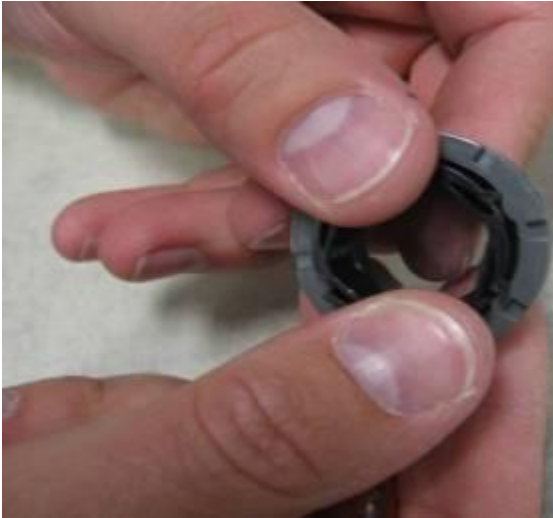
**Black notch**

**Grey tab**

**Black notch not on this side of grey tab**

**Black notch on this side of grey tab**

5. The inner clutch is always damaged when removed from the scope. Do not reuse the old inner and outer clutches. Align the notch on the inner clutch with the notch on the outer clutch as shown below. If you misalign the inner clutch, you will damage it when you press it into place. The mechanical design makes it hard to press a misaligned inner clutch into the outer clutch, but if you try hard enough, you can damage the inner clutch. Press the new inner clutch into the outer clutch. When properly aligned, it will still take a lot of finger pressure to press the inner clutch into the outer clutch.
