## S E R V I C E N O T E

**E1610A 34 Mb/s E3 Line Interface for Broadband Series****Serial Numbers:** AU3336450 / AU40080500**Errors generated in 34M PLPC Mode****To Be Performed By:** Agilent-Qualified Personnel**Parts Required:** 1821-0992 XC4005 FPGA**Situation:**

Errors generated in 34M PLPC Mode

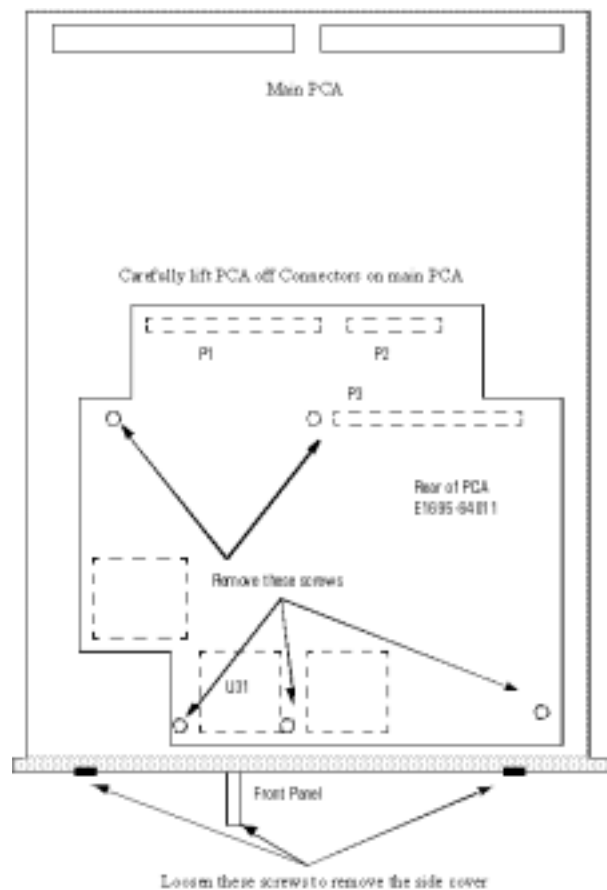
**Figure 1. Location of screws and U31**

**Part Affected** Part Number: 1821-0992**Solution / Action:**

- (1) Undo the torx screws on the top shield of the module and loosen or remove the front panel screws as needed to remove the top shield.
- (2) Remove the U31 as identified in the diagram above and exchange it with the replacement part
- (3) Run the system download utility to reload the firmware into the module. (This is performed from the system mainframe using the media supplied with the system.)
