## S E R V I C E N O T E

**E1650A 75000 Series 90 Modular SONET/SDH Analyzer****Serial Numbers:**

**Disabling of ECLTRIG1 Line on E1405A or E1405B Command Module  
due to incorrect pin connection on E1672A or E1674A Transport  
Overhead Module.**

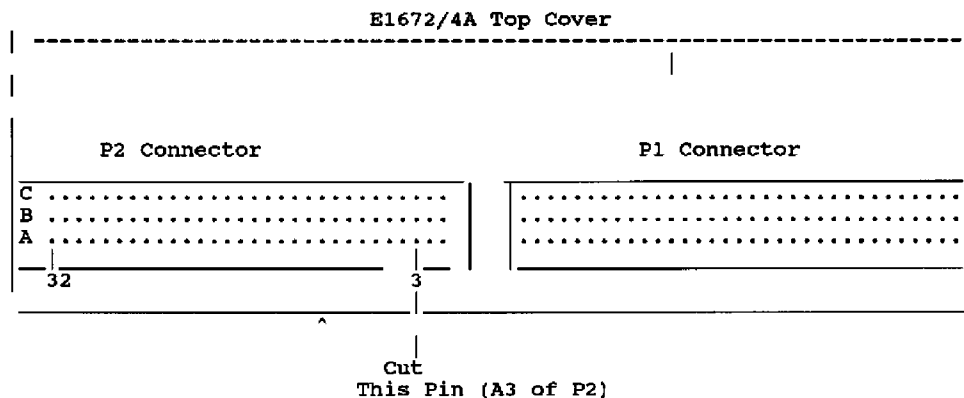
**Figure 1**

75000 Series 90 Modular Sonet/SDH Analyzers with Transport Overhead Modules with Serial numbers as shown above have a -5.2 volt supply incorrectly connected to pin A3 of the P2 connector of the E1672A and E1674A. This connects via the E1400B VXI Mainframe backplane, to the ECLTRG1 output of the E1405A/B. This causes the ECLTRG1 output to be rendered inoperative. This will not in any way affect the operation of the Series 90 but will affect any VXI modules which use the ECLTRG1 output and are used in the same mainframe as the Series 90.

Using the cutters recommended, clip pin A3 of the P2 connector on the E1672/4A module, off at the connector base so that it cannot make contact with the corresponding socket in the mainframe backplane. Be sure to capture the off cut of the pin to ensure that it cannot cause damage.

Refer to figure 1 below to locate the correct pin.

Cut pin A3 of P2 with due care. Be careful not to bend adjacent pins
