E3939A/B-02-S

S E R V I C E N O T E

HP E3939A/B PT500 Protocol Tester

DATE: 03 January 1994

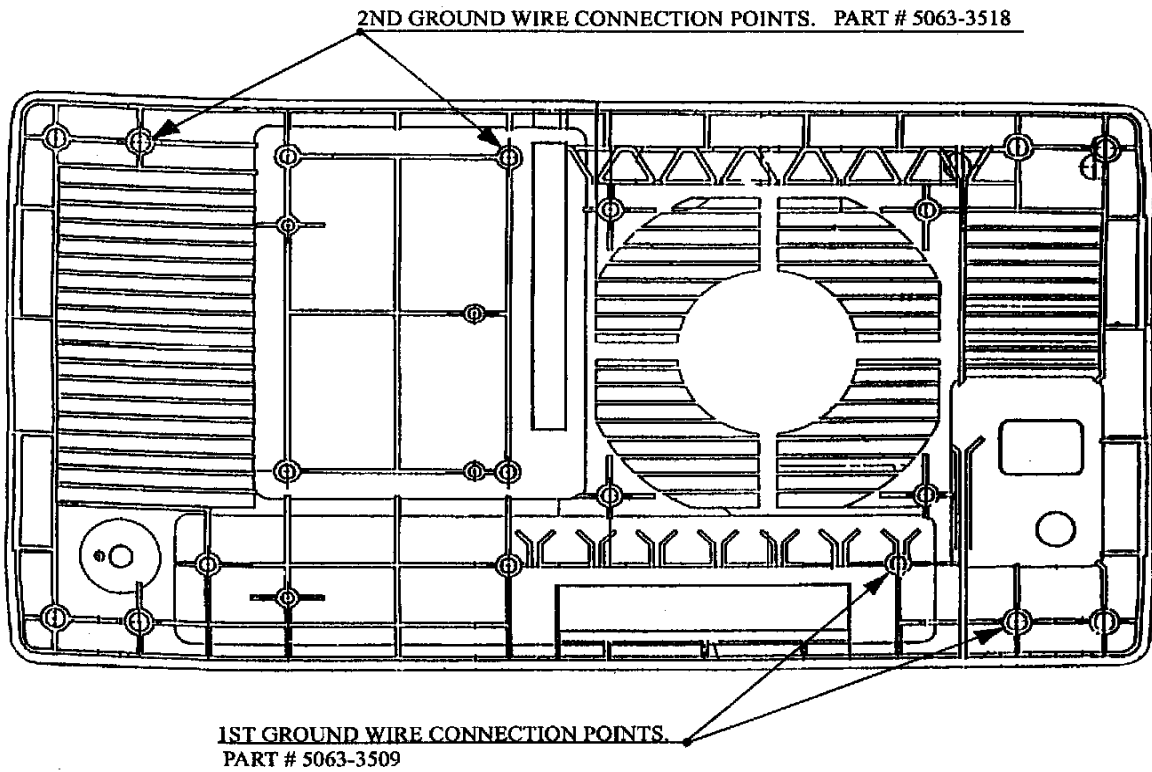
PT BACK BEZEL GROUNDING WIRES UPGRADE

A situation exists in which a unit in the referenced serial number range could possibly become a shock hazard to personnel. This situation would likely only occur if high voltage is present on the connector module plane or connector module handle and the existing ground path was blown away. The existing ground path is insufficient to carry current specified by Hewlett-Packard safety requirements. This situation has occurred to date only when checking the unit with a megger or similar device.

- Remove top cover of instrument and interface module.
- Install longer (11 cm) ground cable, p/n 5063-3518, to existing screw of upper left hand side member bracket hole.
- Connect to inside connector module hole, beside degaussing board, with 4x5 screw.

- Remove bottom cover of instrument and auxilliary connector module.
- Install 8 cm ground cable, p/n 5063-3509, to right hand side hole of auxilliary connector with 4x5 screw.

- Connector module handle should be grounded from the rear handle screw to the nearest DB style connector screw by installing one of the 5063-3510 wires between these two points.
- Use the four 4x28 screws to reinstall connector module.

- Applies only to MPT368.2, IPT468, XPE systems with no parallel printer connector, that is, with auxilliary connector module 4010-0070-IDA.
- Install grounding wire between the handle mounting screw and the nearest screw of the "PRINTER" connector.
- Reinstall auxilliary connector module using three 4x25 screws.
