# E4093A/B-02-S

## S E R V I C E N O T E

### HP E4093A/B PT500 Protocol Tester

DATE: 03 January 1994

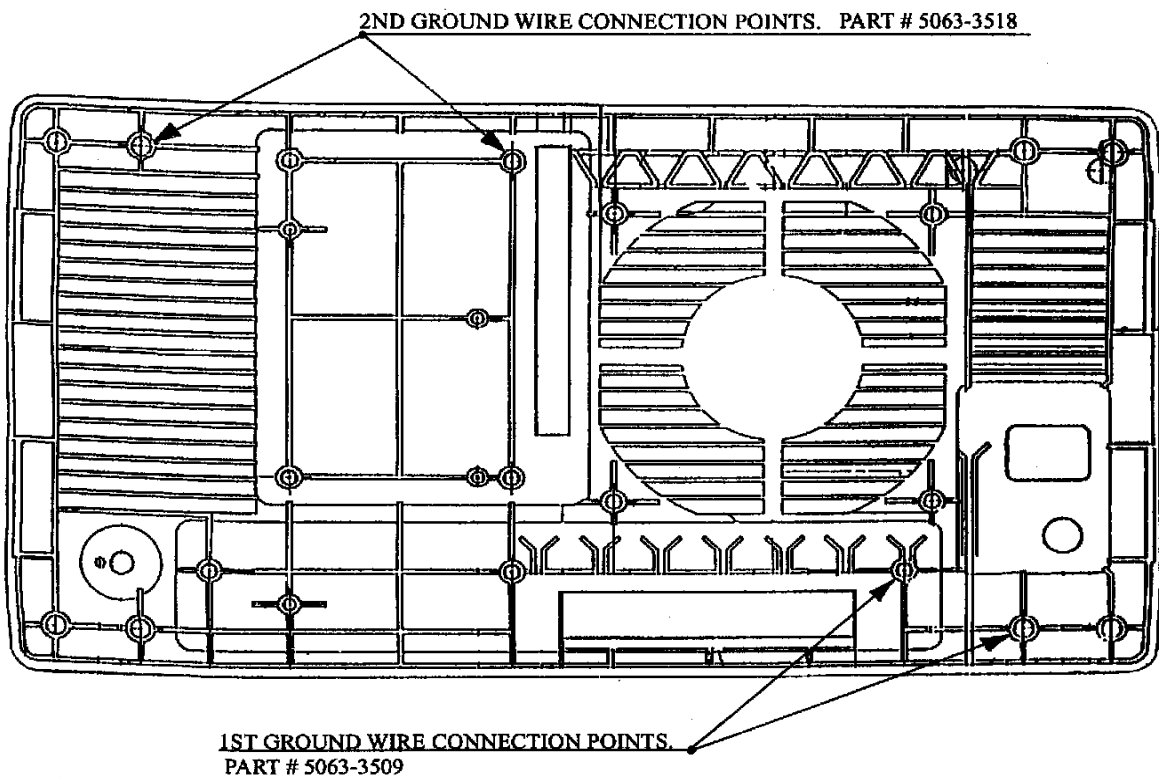
### PT BACK BEZEL GROUNDING WIRES UPGRADE

**High voltage applied to the connector module plane or connector module handle could cause the existing ground path to open, resulting in a possible shock hazard to the user.**

A situation exists in which a unit in the referenced serial number range could possibly become a shock hazard to personnel. This situation would likely only occur if high voltage is present on the connector module plane or connector module handle and the existing ground path was blown away. The existing ground path is insufficient to carry current specified by Hewlett-Packard safety requirements. This situation has occurred to date only when checking the unit with a megger or similar device.

Affected units must be retrofitted with grounding wires to rectify the problem, using the following instructions.

- Remove top cover of instrument and interface module.
- Install longer (11 cm) ground cable, p/n 5063-3518, to existing screw of upper left hand side member bracket hole.
- Connect to inside connector module hole, beside degaussing board, with 4x5 screw.

- Remove bottom cover of instrument and auxilliary connector module.
- Install 8 cm ground cable, p/n 5063-3509, to right hand side hole of auxilliary connector with 4x5 screw.

- Connector module handle should be grounded from the rear handle screw to the nearest DB style connector screw by installing one of the 5063-3510 wires between these two points.
- Use the four 4x28 screws to reinstall connector module.

- Applies only to MPT368.2, IPT468, XPE systems with no parallel printer connector, that is, with auxilliary connector module 4010-0070-IDA.
- Install grounding wire between the handle mounting screw and the nearest screw of the "PRINTER" connector.
- Reinstall auxilliary connector module using three 4x25 screws.
