E4100B-02-S

S E R V I C E N O T E

HP E4100B PT500 Protocol Tester

Serial Numbers: CA33130001/CA33150006

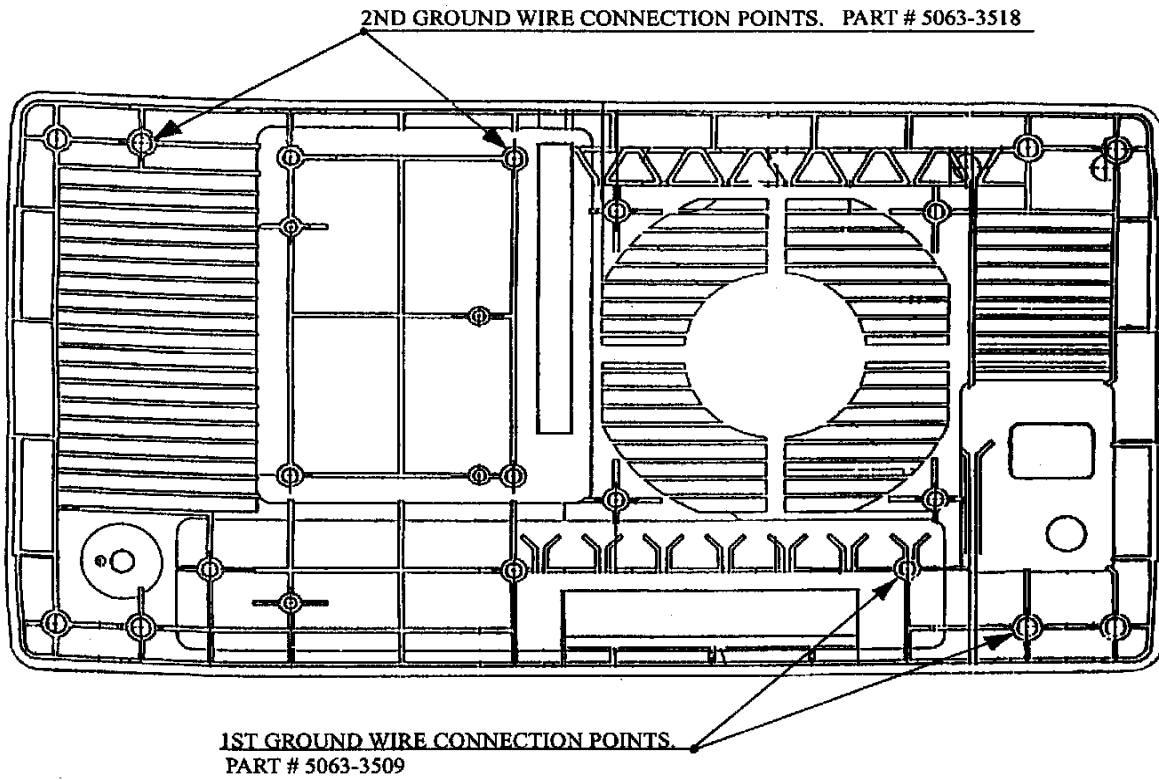
PT BACK BEZEL GROUNDING WIRES UPGRADE

A situation exists in which a unit in the referenced serial number range could possibly become a shock hazard to personnel. This situation would likely only occur if high voltage is present on the connector module plane or connector module handle and the existing ground path was blown away. The existing ground path is insufficient to carry current specified by Hewlett-Packard safety requirements. This situation has occurred to date only when checking the unit with a megger or similar device.

- Remove top cover of instrument and interface module.
- Install longer (11 cm) ground cable, p/n 5063-3518, to existing screw of upper left hand side member bracket hole.
- o Connect to inside connector module hole, beside degaussing board, with 4x5 screw.

- Remove bottom cover of instrument and auxilliary connector module.
- Install 8 cm ground cable, p/n 5063-3509, to right hand side hole of auxilliary connector with 4x5 screw.

- o Connector module handle should be grounded from the rear handle screw to the nearest DB style connector screw by installing one of the 5063-3510 wires between these two points.
- Use the four 4x28 screws to reinstall connector module.

- Applies only to MPT368.2, IPT468, XPE systems with no parallel printer connector, that is, with auxilliary connector module 4010-0070-IDA.
- Install grounding wire between the handle mounting screw and the nearest screw of the "PRINTER" connector.
- Reinstall auxilliary connector module using three 4x25 screws.
