E4356A-02A

S E R V I C E N O T E

**E4356A TELECOM DC OWER SUPPLY GPIB
CONTROLLED**

**The Current Shunt (Circuit Reference “R907”) may have intermittent sense
wires, which may cause Instability of Current regulation, Current read back and
current programming.**

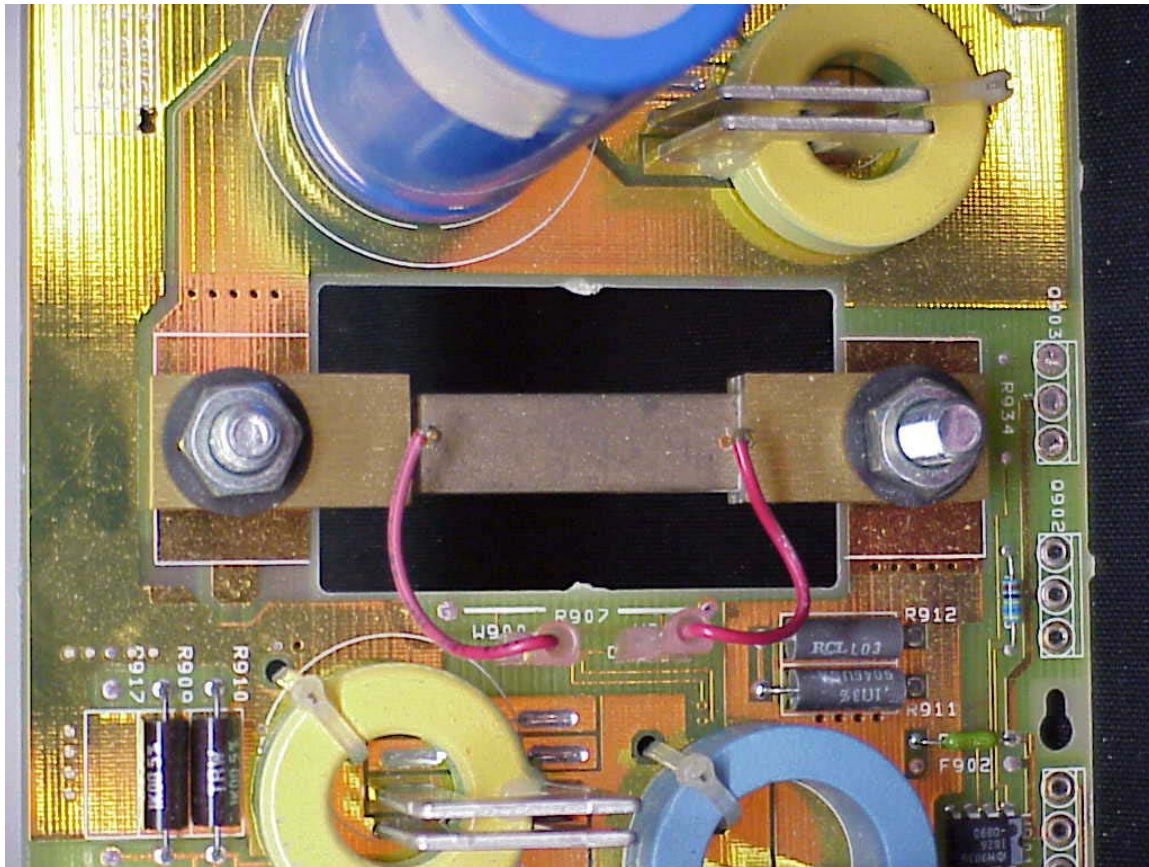
When the push-on connectors become intermittent the output current will become unstable. Loose push-on connectors can cause the output current to change dramatically. The current can change from any set current, and may go to the maximum rated output current of the instrument.

This picture shows how the Shunt R907 is connected using the term-crimp connectors.

The Shunt R907 is connected to "W900" & "W901"
