S E R V I C E N O T E

E4401B, E4402B, E4403B, E4404B, E4405B, E4407B, E4408B, and E4411B ESA Spectrum Analyzer family. Also E7401A, E7402A, E7403A, E7404A, and E7405A EMC Pre-Compliance Analyzers.

Intermittent screen "flicker" due to a cold solder joint

DATE: January 2001

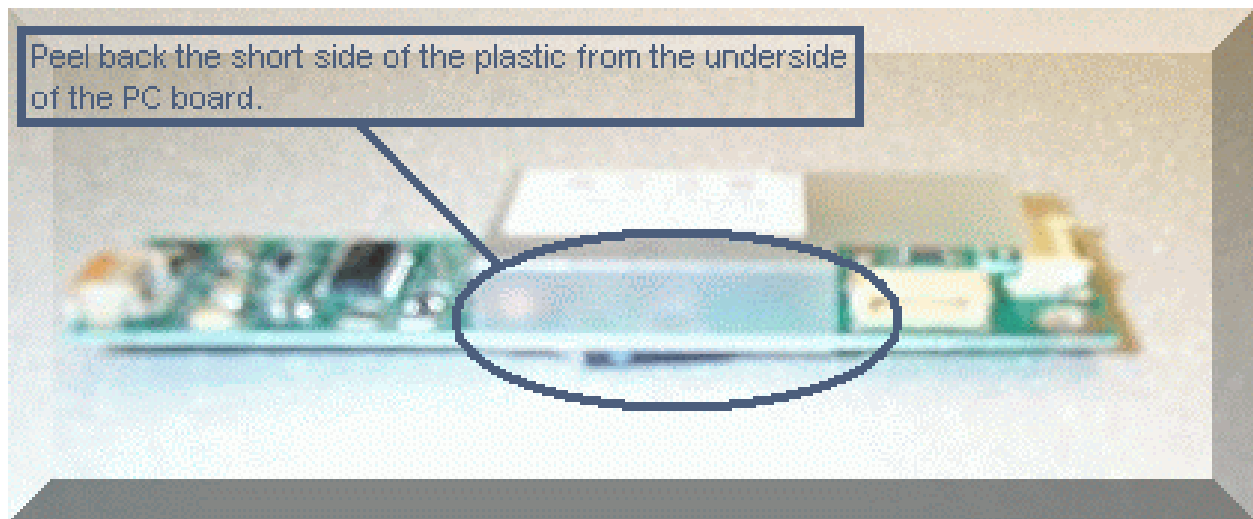
Figure 1

Instruments within the above serial range can experience an intermittent screen "flicker" due to a cold solder joint on pin 7 of the transformer on the backlight inverter board. The backlight inverter board attaches to the front panel interface board (A1A1) on the analyzer. The attached figures below in the Solution/Action section can be referenced on the procedure to use to correct for this problem.

- 1) Peel back the plastic shield on the backlight inverter board. See Figure 1.
