S E R V I C E N O T E

E4401B, E4402B, E4403B, E4404B, E4405B, E4407B, E4408B, and E4411B ESA Spectrum Analyzer family. Also E7401A, E7402A, E7403A, E7404A, and E7405A EMC Pre-Compliance Analyzers.

Intermittent screen "flicker" due to a cold solder joint

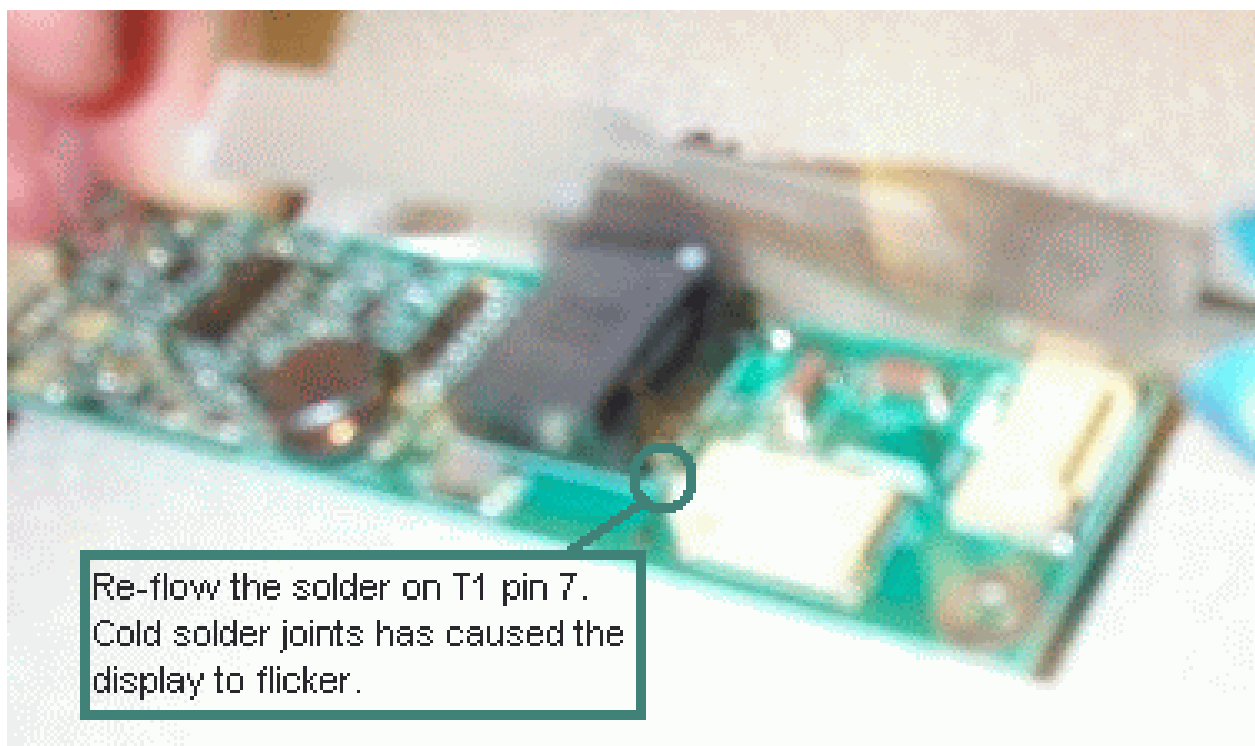
Figure 3

Instruments within the above serial range can experience an intermittent screen "flicker" due to a cold solder joint on pin 7 of the transformer on the backlight inverter board. The backlight inverter board attaches to the front panel interface board (A1A1) on the analyzer. The attached figures below in the Solution/Action section can be referenced on the procedure to use to correct for this problem.

The backlight inverter board and LCD display are procured together as an assembly from NEC. Manufacturing has troubleshot screen flicker issues to poor solder quality on pin 7 of the transformer on the backlight inverter board. NEC has been notified and an inspection process implemented in manufacturing to cure this problem.

3) Re-solder pin 7 of the transformer on the backlight inverter board. See Figure 3.
