E4411B-08

S E R V I C E N O T E

E4411B 1.5 GHz Spectrum Analyzer

Firmware Update to Fix High Noise Floor on the Analyzer Screen.

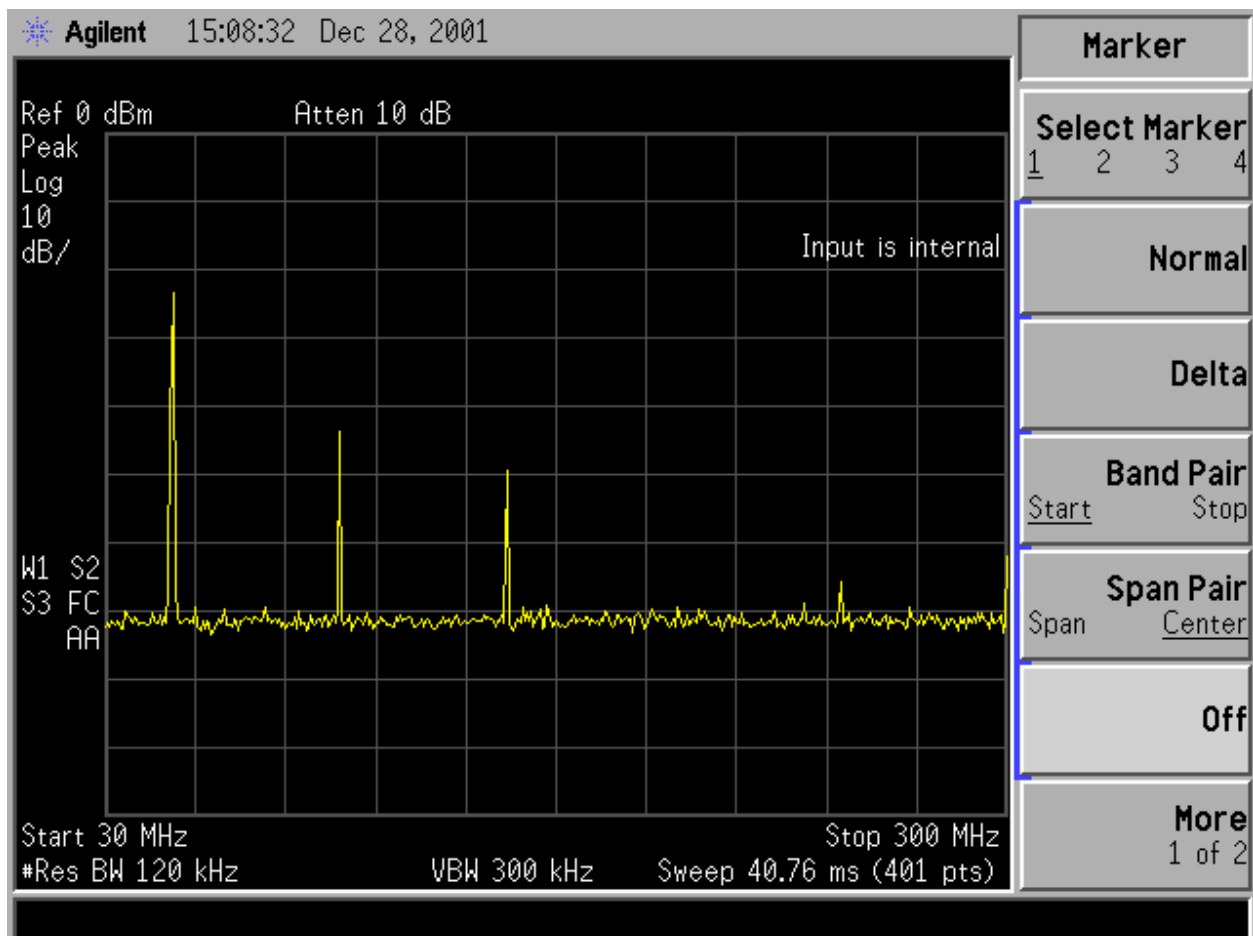
You should see the Alignment signal (50 MHz) and harmonics on screen as shown below.

Press System, More 1 of 3, More 2 of 3, Service –2010 Enter, Service, Align, LO. If the instrument is affected, then either the Align signal & harmonics will disappear or they will move around quickly and erratically on screen. If this occurs, contact the customer and verify the latest shipping version of ESA firmware can be upgraded in their instrument. If the instrument has option B72, Expanded Memory the instrument can be upgraded to the latest and greatest firmware. Otherwise, A.07.05 is the
