**E4416A-10**

# S E R V I C E N O T E

## Agilent E4416A EPM-P Peak & Average Power Meter

### Front Panel Dimension Might Not Be Suitable For Rack Mounting Solutions

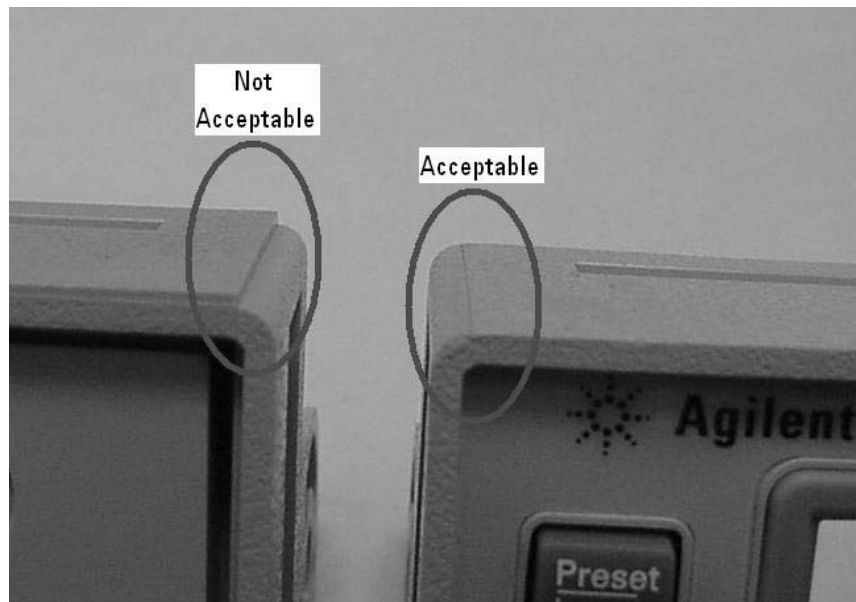
A tooling issue has resulted in some E4416A power meters being shipped with excess material on the top edge of the Front Panel Assembly. The height of this excess material varies, but it has been noted that when it exceeds 0.5mm the meter may no longer be suitable for rack mounting solutions.

Figure 1 shows the physical difference between an acceptable and an unacceptable Front Panel Assembly.

If the height of the excess material is 0.5mm (or less), then no further action is necessary.

If the height of the material exceeds 0.5mm, then the Front Panel Sub-assembly must be replaced (refer to Service Note E4416A-08 for instructions on how to remove & replace the Front Panel Sub-Assembly).
